## General Information

| Make | Suzuki | Model | Jimny |
| YOM | 2024 | Odo Meter Reading | 42 |
| Registration No. | DCG7788 | Chassis No. | MA3JC74W1R0155072 |

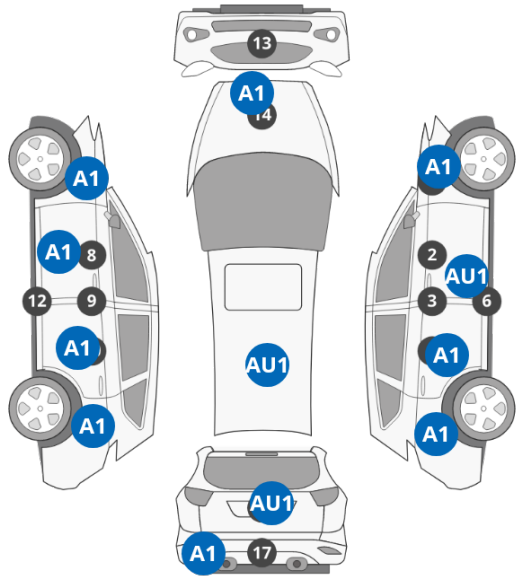
| Interior Evaluation : <b>A</b> | Exterior Evaluation : <b>A</b> |
| <p><b>Remarks</b><br/>Defects not found</p> | <p><b>Remarks</b><br/>(R) Front Door, Molding - Scratch &amp; Dent - Minimal / (R) Rear Door, Molding - Scratch - Minimal / (R) Rear Fender, Molding - Scratch - Minimal / Roof - Scratch &amp; Dent - Minimal / (L) Front Fender, Molding - Scratch - Minimal / (L) Front Door, Molding - Scratch - Minimal / (L) Rear Door, Molding - Scratch - Minimal / (L) Rear Fender, Molding - Scratch - Minimal / Trunk Hood, Rear Gate - Scratch &amp; Dent - Minimal / Rear Bumper, Lamps, Panels - Scratch - Minimal / Bonnet, Headlight - Scratch - Minimal / (R) Front Fender, Molding - Scratch - Minimal</p> |

| Inspector Notes |
|---|
| <p>with LTO plate, with warranty and manual booklet, with reverse camera, with spare tire and key, minor scratches and dent on exterior, scratches in taillight and headlight, engine bay unusual noise when ac is on.</p> |
