## General Information

| Make | Suzuki | Model | Dzire |
| Registration No. | KAR9502 | Chassis No. | MBHZF63S4RG476420 |

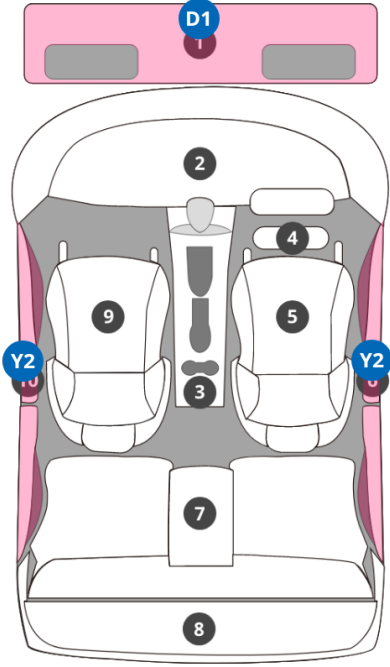
| Interior Evaluation : <b>A</b> | Exterior Evaluation : <b>D</b> |
|---|---|
| <p><b>Remarks</b><br/>(L) Front Trim - Grime - Small / (R) Front Trim - Grime - Small / Ceiling - Crinkle - Minimal</p> | <p><b>Remarks</b><br/>(R) Front Fender, Molding - Scratch - Small / (R) Mirror - Scratch - Medium / (R) Front Door, Molding - Scratch - Minimal / (R) Rear Door, Molding - Scratch - Large / (R) Step, In-panel, Side Spoiler - Scratch &amp; Dent - Large / (R) Rear Fender, Molding - Scratch - Minimal / (L) Front Fender, Molding - Scratch - Minimal / (L) Mirror - Scratch - Small / (L) Front Door, Molding - Scratch - Small / (L) Step, In-panel, Side Spoiler - Scratch - Minimal / (L) Rear Door, Molding - Scratch - Small / (L) Rear Fender, Molding - Scratch - Minimal / Front Bumper, Grille, Lamps - Scratch - Large / Bonnet, Headlight - Rust, Corrosion - Small / Trunk Hood, Rear Gate - Scratch - Minimal / Rear Bumper, Lamps, Panels - Scratch - Minimal</p> |

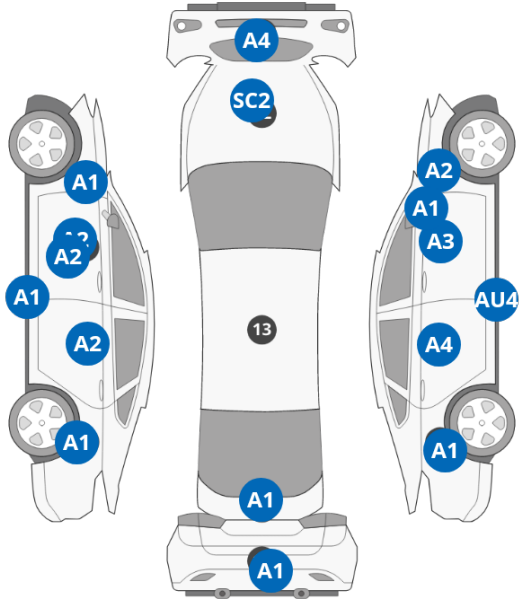
With LTO plate, with warranty booklet, with tools, with jack, with seat cover, with spare tire, no spare key, with warning device, with hairline scratches, no reverse camera.
