## General Information

| Make | Toyota | Model | Vios |
| YOM | 2023 | Odo Meter Reading | 76,209 |
| Registration No. | GAP5199 | Chassis No. | PA1B18F35N4199881 |

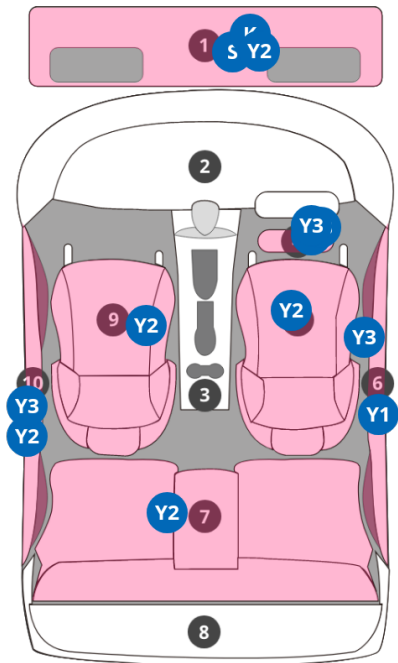
| Interior Evaluation : <b>C</b> | Exterior Evaluation : <b>E</b> |
| <p><b>Remarks</b></p> <p>Rear Seat - Grime - Small / (L) Rear Trim - Grime - Small / (R) Rear Trim - Grime - Minimal / Mat Other - Grime - Small / (R) Front Seat - Grime - Small / (R) Front Floor Mat - Grime - Medium / (R) Front Trim - Grime - Medium / (L) Front Trim - Grime - Medium / (L) Front Seat - Grime - Small / Overall Interior - Smell - Yes / Overall Interior - Animal Hair - Yes / Ceiling - Grime - Small / (L) Front Floor Mat - Grime - Medium</p> | <p><b>Remarks</b></p> <p>Front Bumper, Grille, Lamps - Crack, Gap - Large / Bonnet, Headlight - Scratch &amp; Dent - Medium / (R) Front Fender, Molding - Scratch &amp; Dent - Large / (R) Front Door, Molding - Scratch - Large / (R) Step, In-panel, Side Spoiler - Scratch &amp; Dent - Large / (R) Rear Door, Molding - Scratch - Large / (R) Rear Fender, Molding - Scratch - Medium / (R) Mirror - Scratch - Minimal / Rear Bumper, Lamps, Panels - Scratch &amp; Dent - Medium / Trunk Hood, Rear Gate - Scratch - Small / (L) Rear Fender, Molding - Scratch - Small / (L) Rear Door, Molding - Scratch - Large / (L) Front Door, Molding - Scratch - Large / (L) Mirror - Scratch - Small / (L) Step, In-panel, Side Spoiler - Scratch - Medium / (L) Front Fender, Molding - Dent - Medium</p> |

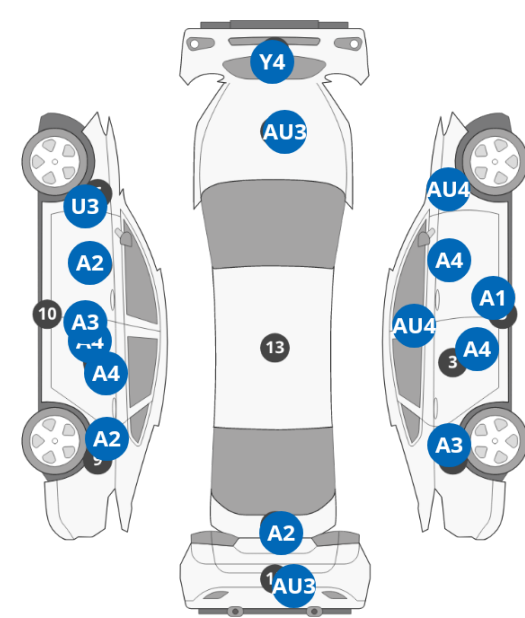
| Inspector Notes |
|---|
| <p>No AC. Large gap at front bumper. Right side retractable mirror issue. Left rear door lock issue. Scratch at Left rear light. Visible hairline scratches. Incomplete tools. With warranty booklet, seatcover, sparetire, jack, LTO Plate and 1key.</p> |
