## General Information

| Make | Toyota | Model | Vios |
| YOM | 2022 | Odo Meter Reading | 82,498 |
| Registration No. | FAJ5997 | Chassis No. | PA1B18F34N4180903 |

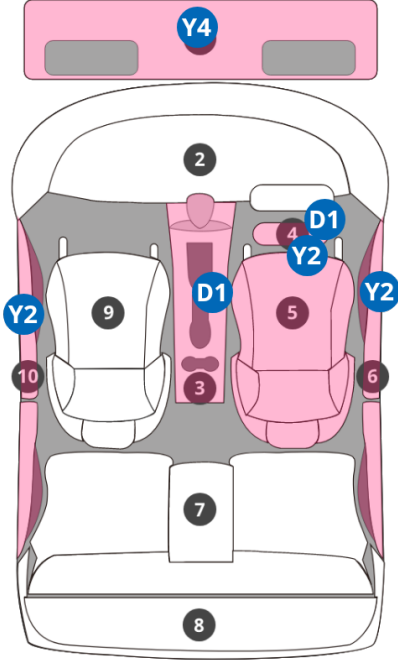
| Interior Evaluation : <b>C</b> | Exterior Evaluation : <b>E</b> |
| <p><b>Remarks</b><br/>Ceiling - Grime - Large / (L) Front Trim - Grime - Small / (R) Front Trim - Grime - Small / Console, Switchs, Vents - Worked - Minimal / (R) Front Seat - Grime - Small / Carpet - Worked - Minimal</p> | <p><b>Remarks</b><br/>(R) Front Fender, Molding - Scratch - Small / (R) Front Door, Molding - Scratch - Small / (R) Rear Door, Molding - Scratch - Small / (R) Rear Fender, Molding - Scratch &amp; Dent - Medium / Rear Bumper, Lamps, Panels - Scratch - Large / (L) Rear Fender, Molding - Scratch &amp; Dent - Large / (L) Rear Door, Molding - Scratch - Small / (L) Front Fender, Molding - Scratch &amp; Dent - Large / Front Bumper, Grille, Lamps - Scratch &amp; Dent - Large / Bonnet, Headlight - Scratch - Small / (L) Front Door, Molding - Scratch - Medium</p> |
