## General Information

| Make | Toyota | Model | Vios |

## Body / Panel Condition

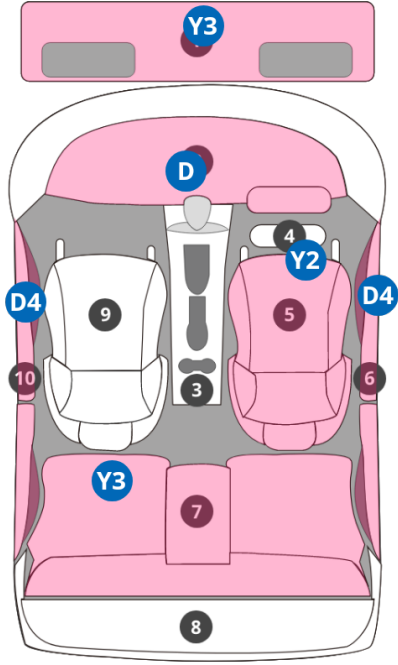
| Interior Evaluation : <span style="color: red;">C</span> | Exterior Evaluation : <span style="color: red;">C</span> |
|---|---|
| <p><b>Remarks</b><br/>Ceiling - Grime - Medium / (R) Front Seat - Grime - Small / Instrument Panel - Traces of Adhesive Tape - Yes / (R) Front Trim - Worked - Large / Rear Seat - Grime - Medium / (L) Front Trim - Worked - Large</p> | <p><b>Remarks</b><br/>(R) Front Door, Molding - Scratch - Medium / (R) Rear Door, Molding - Scratch - Large / Rear Bumper, Lamps, Panels - Scratch &amp; Dent - Medium</p> |
