## General Information

| Make | Toyota | Model | Vios |
| YOM | 2021 | Odo Meter Reading | 51,549 |
| Registration No. | FAF4002 | Chassis No. | PA1B18F31M4134217 |

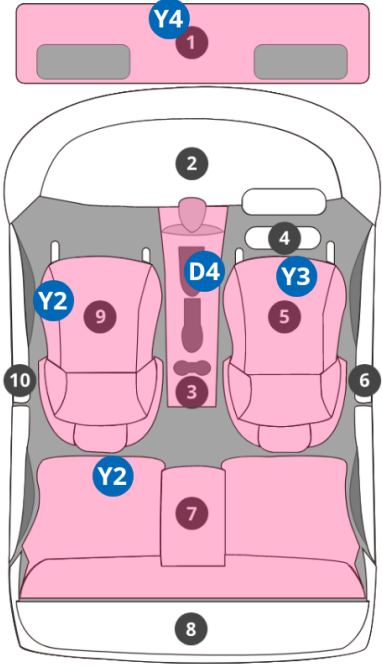
| Interior Evaluation : <span style="color: red;">C</span> | Exterior Evaluation : <span style="color: red;">D</span> |
|---|---|
| <b>Remarks</b><br>Ceiling - Grime - Large / (R) Front Seat - Grime - Medium / Console, Switchs, Vents - Worked - Large / Rear Seat - Grime - Small / (L) Front Seat - Grime - Small / Room Mirror - Missing - Yes | <b>Remarks</b><br>(R) Front Fender - Repair Traces - Yes / (L) Front Fender - Repair Traces - Yes / Trunk Hood, Rear Gate - Repair Traces - Yes / (R) Front Fender, Molding - Modified - Large / (R) Front Door, Molding - Scratch - Small / (R) Rear Door, Molding - Scratch - Small / (R) Step, In-panel, Side Spoiler - Dent - Small / Rear Bumper, Lamps, Panels - Scratch - Medium / Trunk Hood, Rear Gate - Scratch & Dent - Large / (L) Front Door, Molding - Scratch - Small / (L) Front Fender, Molding - Modified - Large / Front Bumper, Grille, Lamps - Scratch - Small |

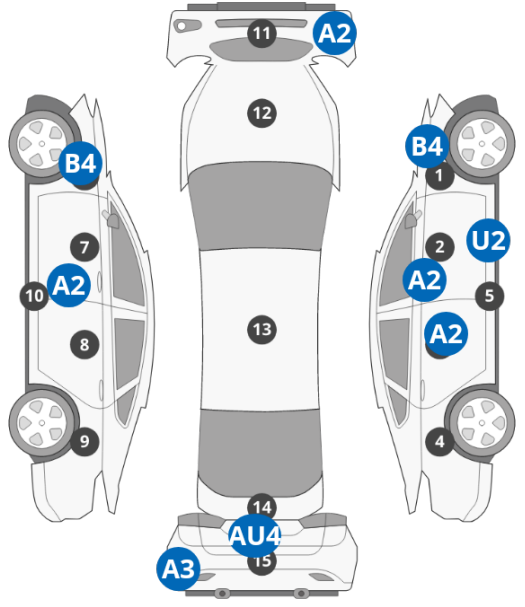
| Inspector Notes |
|---|
| Ito plates not installed, no warranty bookket, jack, tools and spare tire. with hairline scratches in the body, sign of burn in the engine, front fenders replaced |
