## General Information

| Make | Toyota | Model | Vios |
| Registration No. | NIJ5606 | Chassis No. | PA1B18F31P4204500 |

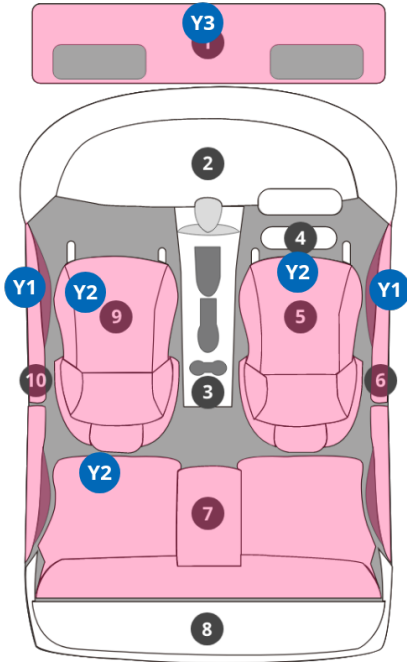
| Interior Evaluation : <b>B</b> | Exterior Evaluation : <b>E</b> |
|---|---|
| <p><b>Remarks</b></p> <p>Ceiling - Grime - Medium / (R) Front Trim - Grime - Minimal / (R) Front Seat - Grime - Small / Rear Seat - Grime - Small / (L) Front Trim - Grime - Minimal / (L) Front Seat - Grime - Small</p> | <p><b>Remarks</b></p> <p>(R) Step - Repair Traces - Yes / (R) Rear Fender - Repair Traces - Yes / (R) Front Fender, Molding - Repair mark - Yes / (R) Front Fender, Molding - Scratch &amp; Dent - Small / (R) Mirror - Scratch - Minimal / (R) Front Door, Molding - Scratch - Small / (R) Step, In-panel, Side Spoiler - Scratch &amp; Dent - Medium / (R) Rear Door, Molding - Repair mark - Yes / (R) Rear Door, Molding - Scratch - Medium / Rear Bumper, Lamps, Panels - Scratch &amp; Dent - Large / Trunk Hood, Rear Gate - Scratch &amp; Dent - Minimal / (L) Rear Fender, Molding - Scratch - Minimal / (L) Rear Door, Molding - Scratch &amp; Dent - Medium / (L) Step, In-panel, Side Spoiler - Scratch &amp; Dent - Small / (L) Front Door, Molding - Scratch - Medium / (R) Rear Fender, Molding - Scratch - Small / (L) Front Fender, Molding - Scratch &amp; Dent - Medium / Front Bumper, Grille, Lamps - Scratch &amp; Dent - Large / Bonnet, Headlight - Scratch &amp; Dent - Small / Roof - Scratch - Minimal / Front Windshield - Scratch, Stone chip - Small</p> |

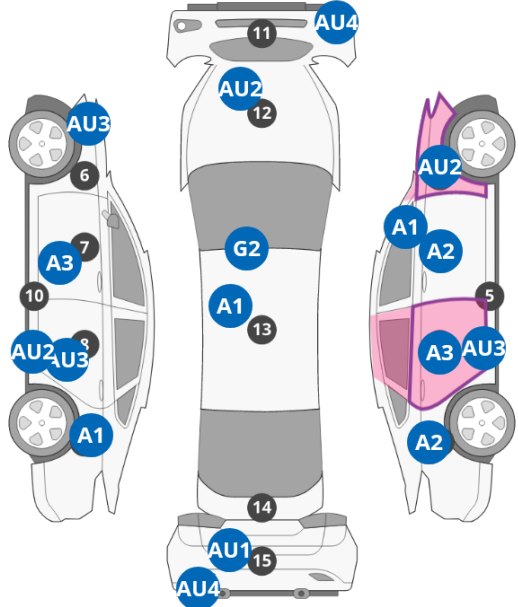
With Lto plate, with spare tire and jack, 2keys, no warranty booklet and tools, scratches on headlights and taillights, worn tires, visible hairlines scratches on vehicle, plate light issue
