## General Information

| Make | Toyota | Model | Wigo |
| YOM | 2022 | Odo Meter Reading | 264,121 |
| Registration No. | EAF3886 | Chassis No. | MHKAA4DE4FNJ004959 |

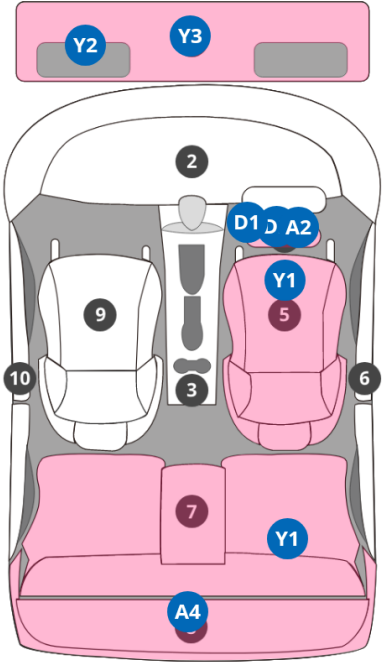
| Interior Evaluation : <b>C</b> | Exterior Evaluation : <b>E</b> |
|---|---|
| <p><b>Remarks</b></p> <p>Ceiling - Grime - Medium / Sunvisor, Sunglass Holder - Grime - Small / Mat Other - Worked - Small / Rear Seat - Grime - Minimal / (R) Front Seat - Grime - Minimal / Trunk Room - Worn, Scratch, Cut, Crack - Large / (L) Front Floor Mat - Cut, Crack - Small / Carpet - Worked - Minimal</p> | <p><b>Remarks</b></p> <p>(R) Front Fender, Molding - Scratch &amp; Dent - Large / (R) Mirror - Scratch - Small / (R) Front Door, Molding - Scratch &amp; Dent - Small / (R) Step, In-panel, Side Spoiler - Scratch &amp; Dent - Large / (R) Rear Door, Molding - Scratch &amp; Dent - Large / (R) Rear Fender, Molding - Scratch &amp; Dent - Large / Rear Bumper, Lamps, Panels - Crack, Gap - Large / Trunk Hood, Rear Gate - Scratch - Small / (L) Rear Fender, Molding - Scratch &amp; Dent - Medium / (L) Rear Door, Molding - Scratch &amp; Dent - Small / (L) Step, In-panel, Side Spoiler - Scratch - Small / (L) Front Door, Molding - Scratch &amp; Dent - Minimal / (L) Mirror - Scratch - Minimal / Roof Spoiler, Molding - Scratch &amp; Dent - Small / Roof - Scratch - Minimal / Bonnet, Headlight - Scratch - Small / Front Bumper, Grille, Lamps - Scratch &amp; Dent - Large / (L) Front Fender, Molding - Scratch - Minimal</p> |

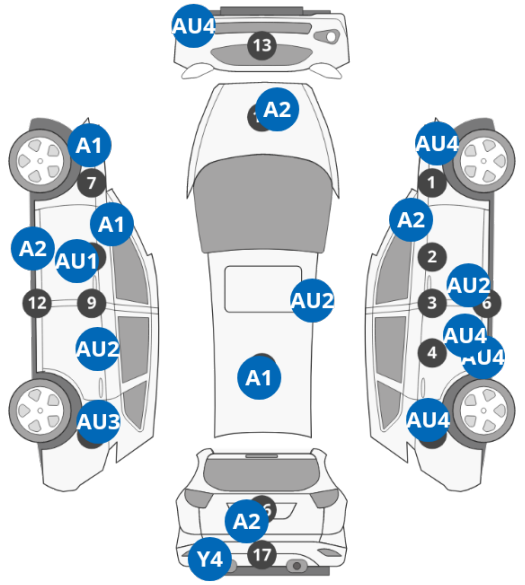
| Inspector Notes |
|---|
| With Lto plate, with spare tire, 1key, no warranty booklet and tools and Jack, scratches on headlights, Crack taillight, trunk cover issue |
