## General Information

| Make | Toyota | Model | Vios |
| YOM | 2023 | Odo Meter Reading | 27,754 |
| Registration No. | NIP1900 | Chassis No. | PA1B18F36P4207313 |

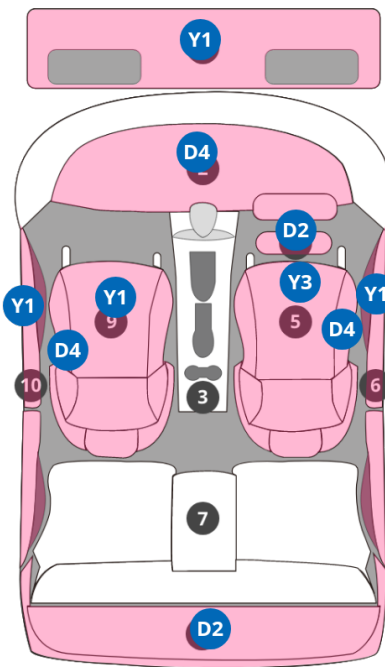
| <div>Interior Evaluation : <span>C</span></div> | <div>Exterior Evaluation : <span>C</span></div> |
| <div> <div>Remarks</div> <div>Ceiling - Grime - Minimal / Dashboard - Loose, Deformed - Large / (L) Front Trim - Grime - Minimal / (L) Front Floor Mat - Worked - Small / (L) Front Seat - Grime - Minimal / Trunk Room - Loose, Deformed - Small / (R) Front Trim - Grime - Minimal / (R) Front Seat - Grime - Medium / (R) Front Seat belt - Loose, Deformed - Large / (L) Front Seat belt - Loose, Deformed - Large</div> </div> | <div> <div>Remarks</div> <div>(R) Front Fender, Molding - Scratch &amp; Dent - Minimal / (R) Mirror - Scratch - Minimal / (R) Front Door, Molding - Scratch &amp; Dent - Minimal / (R) Rear Door, Molding - Scratch &amp; Dent - Small / (R) Step, In-panel, Side Spoiler - Scratch - Minimal / (R) Rear Fender, Molding - Scratch - Minimal / Roof - Scratch &amp; Dent - Minimal / Rear Bumper, Lamps, Panels - Scratch &amp; Dent - Medium / Trunk Hood, Rear Gate - Dent - Small / (L) Rear Fender, Molding - Scratch &amp; Dent - Large / (L) Rear Door, Molding - Scratch &amp; Dent - Small / (L) Front Door, Molding - Scratch &amp; Dent - Minimal / (L) Step, In-panel, Side Spoiler - Scratch - Minimal / (L) Front Fender, Molding - Scratch - Minimal / Front Bumper, Grille, Lamps - Scratch &amp; Dent - Small / Bonnet, Headlight - Scratch - Minimal</div> </div> |

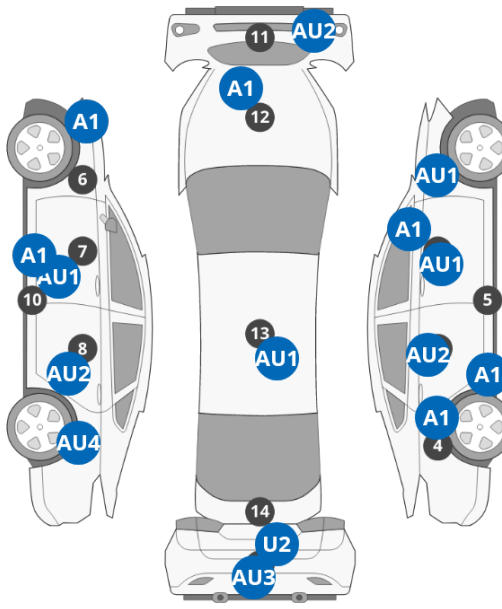
With Lto plate, with warranty booklet and tools and Jack, 1key, no spare tire, scratches on headlights and taillights, traction control lamp on, AIRBAG warning lamp on, ABS warning lamp on,
