## General Information

| Make | Toyota | Model | Vios |
| Registration No. | CCA3327 | Chassis No. | PA1B18F31P4227839 |

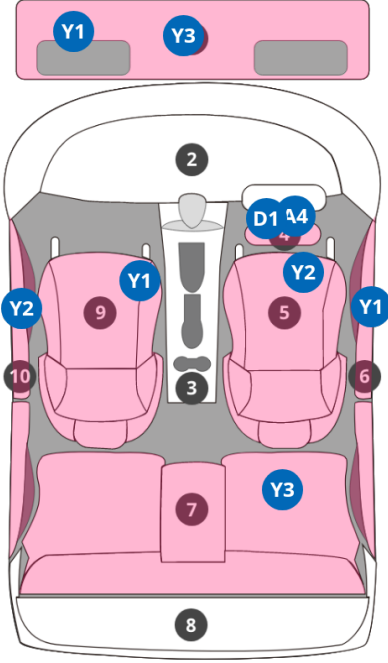
| Interior Evaluation : <b>C</b> | Exterior Evaluation : <b>E</b> |
|---|---|
| <p><b>Remarks</b></p> <p>Ceiling - Grime - Medium / Sunvisor, Sunglass Holder - Grime - Minimal / Rear Seat - Grime - Medium / (R) Front Trim - Grime - Minimal / (R) Front Seat - Grime - Small / (L) Front Trim - Grime - Small / (L) Front Floor Mat - Cut, Crack - Large / Carpet - Worked - Minimal / (L) Front Seat - Grime - Minimal</p> | <p><b>Remarks</b></p> <p>(R) Front Fender, Molding - Scratch - Minimal / (R) Front Door, Molding - Scratch &amp; Dent - Small / (R) Step, In-panel, Side Spoiler - Scratch - Small / (R) Rear Door, Molding - Scratch - Minimal / (R) Rear Fender, Molding - Scratch - Minimal / Rear Bumper, Lamps, Panels - Scratch &amp; Dent - Medium / Trunk Hood, Rear Gate - Scratch &amp; Dent - Small / (L) Rear Fender, Molding - Scratch &amp; Dent - Large / (L) Rear Door, Molding - Scratch - Large / (L) Front Door, Molding - Scratch - Small / (L) Mirror - Scratch - Minimal / (R) Mirror - Scratch - Minimal / (L) Front Fender, Molding - Scratch - Minimal / Front Bumper, Grille, Lamps - Scratch - Large / Bonnet, Headlight - Scratch &amp; Dent - Small / (L) Step, In-panel, Side Spoiler - Scratch - Small / Roof - Scratch &amp; Dent - Small / Roof Spoiler, Molding - Scratch - Small</p> |

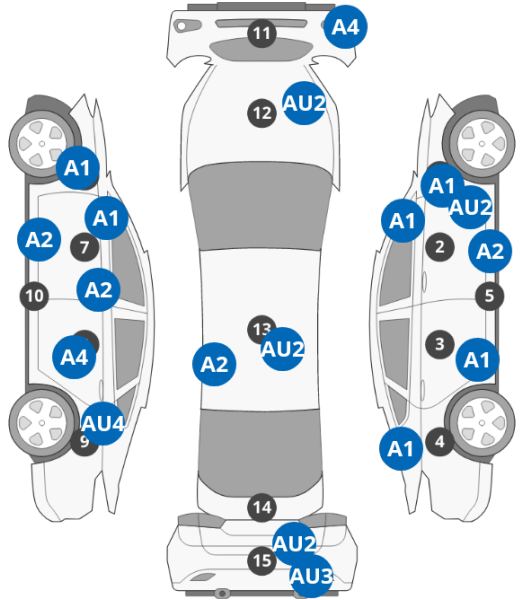
With Lto plate, with spare tire and jack, 2keys, no warranty booklet and tools, scratches on headlights and taillights, left fender light issue,
