## General Information

| Make | Toyota | Model | Rush |
| Registration No. | CBT9374 | Chassis No. | MHKE8FF3PPK053188 |

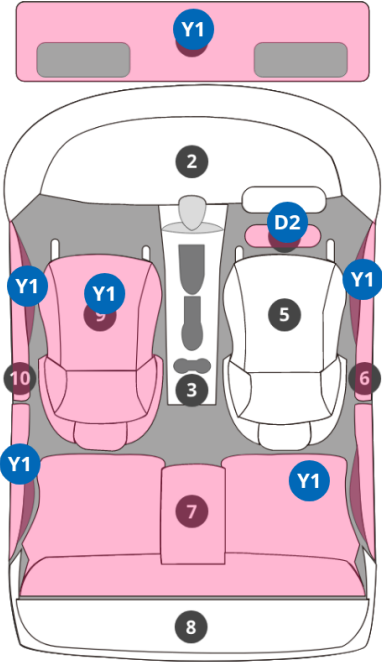
| Interior Evaluation : <span style="color: red; font-weight: bold;">A</span> | Exterior Evaluation : <span style="color: red; font-weight: bold;">C</span> |
|---|---|
| <b>Remarks</b><br>Ceiling - Grime - Minimal / Rear Seat - Grime - Minimal / (R) Front Trim - Grime - Minimal / (L) Rear Trim - Grime - Minimal / (L) Front Trim - Grime - Minimal / (L) Front Floor Mat - Worked - Small / (L) Front Seat - Grime - Minimal | <b>Remarks</b><br>(R) Front Fender, Molding - Scratch - Minimal / (R) Mirror - Scratch - Minimal / (R) Front Door, Molding - Scratch - Small / (R) Step, In-panel, Side Spoiler - Scratch - Medium / (R) Rear Door, Molding - Scratch - Medium / (R) Rear Fender, Molding - Scratch - Minimal / Roof - Scratch - Minimal / Trunk Hood, Rear Gate - Scratch - Minimal / Rear Bumper, Lamps, Panels - Scratch & Dent - Small / (L) Rear Fender, Molding - Scratch & Dent - Minimal / (L) Rear Door, Molding - Scratch - Minimal / (L) Front Door, Molding - Scratch & Dent - Minimal / (L) Step, In-panel, Side Spoiler - Scratch - Small / (L) Front Fender, Molding - Scratch - Small / Front Bumper, Grille, Lamps - Scratch - Medium / Bonnet, Headlight - Scratch - Minimal / (L) Mirror - Scratch - Minimal |

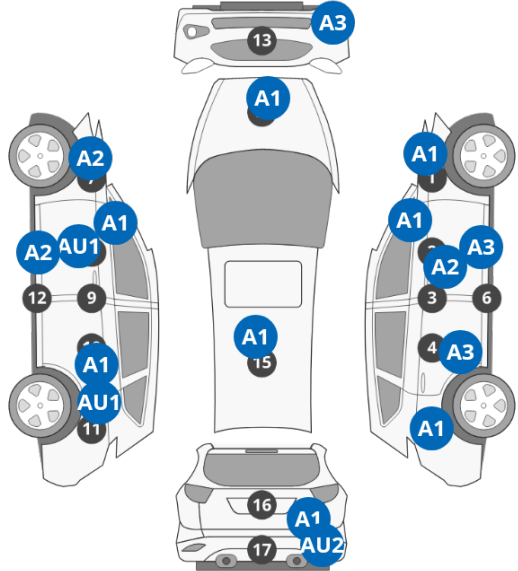
| Inspector Notes |
|---|
| With Lto plate, with spare tire and jack, with warranty booklet, 2keys, no tools, battery weak, visible hairlines scratches on vehicle, |
