## General Information

| Make | Toyota | Model | Vios |

## Body / Panel Condition

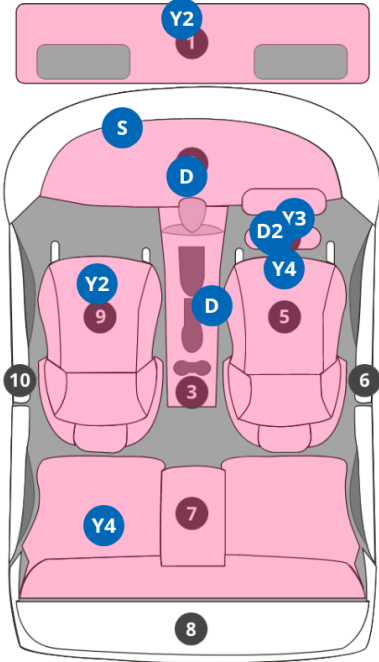
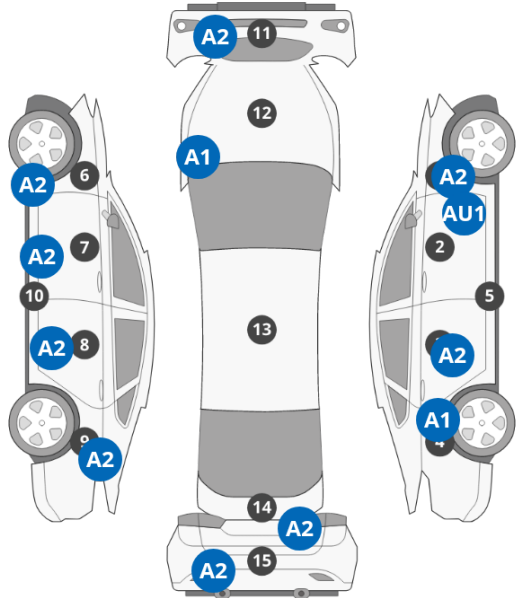
| Interior Evaluation : <span style="color: red;">C</span> | Exterior Evaluation : <span style="color: red;">C</span> |
|---|---|
| <p><b>a</b> : Cut, Fray <b>d</b> : Loose, Deformed <b>k</b> : Animal Hair <b>s</b> : Smell <b>t</b> : Cigarette Burns <b>x</b> : Defective <b>y</b> : Stain</p> | <p><b>A</b> : Scratch <b>AU</b> : Scratch &amp; Dent <b>B</b> : Modified <b>C</b> : Corrosion <b>G</b> : Stone chip <b>P</b> : Faded <b>S</b> : Rust <b>SC</b> : Rust &amp; Corrosion <b>U</b> : Dent <b>X</b> : Defective <b>Y</b> : Crack, Gap</p> |
| <p><b>Remarks</b></p> <p>Mat Other - Grime - Large / Rear Seat - Grime - Large / (R) Front Floor Mat - Grime - Medium / (R) Front Seat - Grime - Large / (L) Front Floor Mat - Worked - Small / Console, Switchs, Vents - Traces of Adhesive Tape - Yes / Instrument Panel - Traces of Adhesive Tape - Yes / Ceiling - Grime - Small / Overall Interior - Smell - Yes</p> | <p><b>Remarks</b></p> <p>(L) Front Door - Repair Traces - Yes / (R) Front Fender, Molding - Scratch - Small / (R) Front Door, Molding - Scratch &amp; Dent - Minimal / (R) Rear Door, Molding - Scratch - Small / (R) Rear Fender, Molding - Scratch - Minimal / Trunk Hood, Rear Gate - Scratch - Small / Rear Bumper, Lamps, Panels - Scratch - Small / (L) Rear Fender, Molding - Scratch - Small / (L) Front Door, Molding - Scratch - Small / Front Bumper, Grille, Lamps - Scratch - Small / (L) Front Fender, Molding - Scratch - Small / Bonnet, Headlight - Scratch - Minimal / (L) Rear Door, Molding - Scratch - Small</p> |
