## General Information

| Make | Toyota | Model | Vios |
| YOM | 2023 | Odo Meter Reading | 20,910 |
| Registration No. | NIH1077 | Chassis No. | PA1B18F33N4197336 |

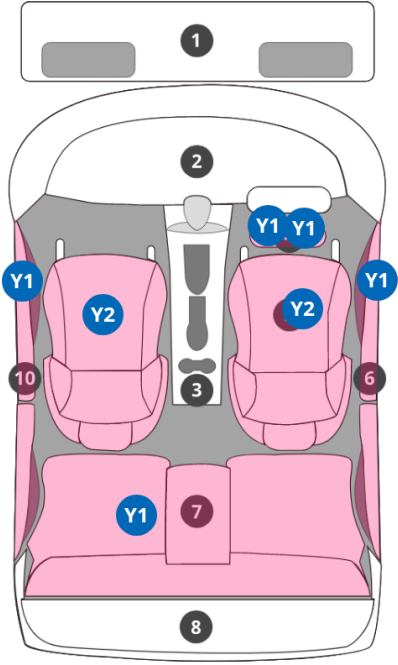
| Interior Evaluation : <b>A</b> | Exterior Evaluation : <b>E</b> |
| <p><b>Remarks</b><br/>(L) Front Seat - Grime - Small / (R) Front Seat - Grime - Small / (R) Front Trim - Grime - Minimal / (L) Front Trim - Grime - Minimal / Rear Seat - Grime - Minimal / (L) Front Floor Mat - Grime - Minimal / (R) Front Floor Mat - Grime - Minimal</p> | <p><b>Remarks</b><br/>(L) Front Fender - Repair Traces - Yes / Bonnet, Headlight - Scratch &amp; Dent - Minimal / Front Bumper, Grille, Lamps - Scratch - Medium / (R) Front Fender, Molding - Scratch &amp; Dent - Small / (R) Front Door, Molding - Scratch &amp; Dent - Small / (R) Rear Door, Molding - Scratch &amp; Dent - Minimal / (R) Rear Fender, Molding - Scratch &amp; Dent - Minimal / Rear Bumper, Lamps, Panels - Scratch - Large / (R) Step, In-panel, Side Spoiler - Scratch &amp; Dent - Medium / (L) Rear Fender, Molding - Scratch &amp; Dent - Minimal / Roof - Scratch - Medium / (L) Rear Door, Molding - Scratch &amp; Dent - Small / (L) Step, In-panel, Side Spoiler - Scratch &amp; Dent - Minimal / (L) Front Door, Molding - Scratch &amp; Dent - Small / (L) Front Fender, Molding - Scratch &amp; Dent - Small / Trunk Hood, Rear Gate - Scratch - Medium / Front Bumper, Grille, Lamps - Repair mark - Yes / Bonnet, Headlight - Repair mark - Yes / (L) Front Fender, Molding - Repair mark - Yes</p> |

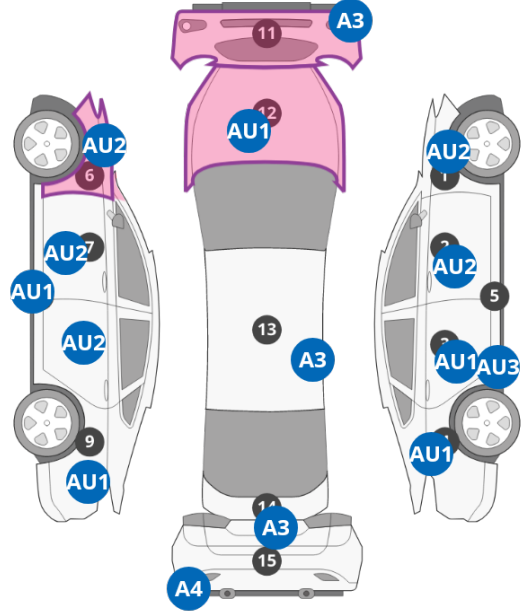
| Inspector Notes |
|---|
| with LTO plate, with spare tire, with jack, no warranty and manual booklet, no spare key, no reverse camera, no tools, scratches and dent on exterior, scratches in taillight and headlight, rear view mirror missing, trunk tire cover missing, whole body have bird drop. |
