## General Information

| Make | Nissan | Model | NV350 |
| YOM | 2018 | Odo Meter Reading | 78,018 |

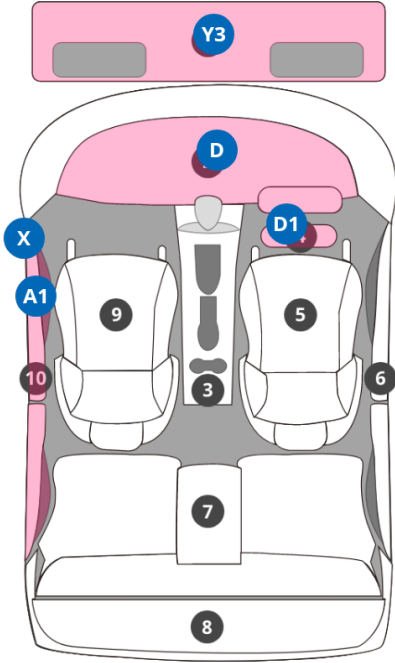
| Interior Evaluation : <b>B</b> | Exterior Evaluation : <b>E</b> |
|---|---|
| <p><b>Remarks</b><br/>Dashboard - Traces of Adhesive Tape - Yes / (L) Front Trim - Cut, Crack - Minimal / Carpet - Worked - Minimal / Ceiling - Grime - Medium / Trim Other - Missing - Yes</p> | <p><b>Remarks</b><br/>Front Panel - Repair Traces - Yes / Trunk Hood, Rear Gate - Repair Traces - Yes / (R) Front Fender, Molding - Scratch - Small / (R) Mirror - Scratch - Minimal / (R) Front Door, Molding - Scratch &amp; Dent - Small / (R) Rear Door, Molding - Scratch &amp; Dent - Small / (R) Step, In-panel, Side Spoiler - Scratch - Small / (R) Rear Fender, Molding - Scratch &amp; Dent - Medium / Rear Bumper, Lamps, Panels - Scratch - Small / Trunk Hood, Rear Gate - Scratch &amp; Dent - Large / (L) Rear Fender, Molding - Scratch &amp; Dent - Medium / (L) Front Door, Molding - Scratch &amp; Dent - Medium / (L) Front Fender, Molding - Scratch - Minimal / (L) Mirror - Scratch - Minimal / Front Bumper, Grille, Lamps - Scratch - Large / (L) Step, In-panel, Side Spoiler - Scratch &amp; Dent - Small / Roof - Scratch - Minimal / Front Panel - Scratch - Minimal</p> |
