## General Information

| Make | Chevrolet | Model | Colorado |

## Body / Panel Condition

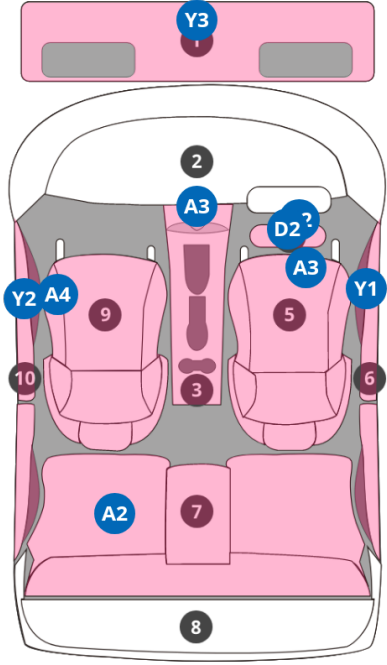
| Interior Evaluation : <b>C</b> | Exterior Evaluation : <b>E</b> |
|---|---|
| <p><b>Remarks</b></p> <p>Ceiling - Grime - Medium / Rear Seat - Fray - Small / Mat Other - Worked - Small / (R) Front Trim - Grime - Minimal / (R) Front Seat - Fray - Medium / (R) Front Floor Mat - Worked - Small / (L) Front Trim - Grime - Small / (L) Front Seat - Cut, Crack - Large / Console, Switchs, Vents - Worn, Scratch, Cut, Crack - Medium</p> | <p><b>Remarks</b></p> <p>(R) Front Fender, Molding - Scratch &amp; Dent - Large / (R) Mirror - Scratch - Minimal / (R) Front Door, Molding - Scratch &amp; Dent - Medium / (R) Rear Door, Molding - Scratch &amp; Dent - Large / (R) Step, In-panel, Side Spoiler - Crack, Gap - Large / (R) Side Gate - Scratch &amp; Dent - Large / Rear Bumper, Lamps, Panels - Scratch &amp; Dent - Large / Rear Gate - Scratch - Minimal / (L) Side Gate - Scratch - Medium / (L) Rear Door, Molding - Scratch &amp; Dent - Minimal / (L) Step, In-panel, Side Spoiler - Crack, Gap - Small / (L) Front Door, Molding - Scratch &amp; Dent - Small / (L) Front Fender, Molding - Scratch &amp; Dent - Large / Front Bumper, Grille, Lamps - Scratch - Large / Bonnet, Headlight - Scratch &amp; Dent - Small / Roof - Crack, Gap - Medium</p> |
