## General Information

| Make | Toyota | Model | Vios |

## Body / Panel Condition

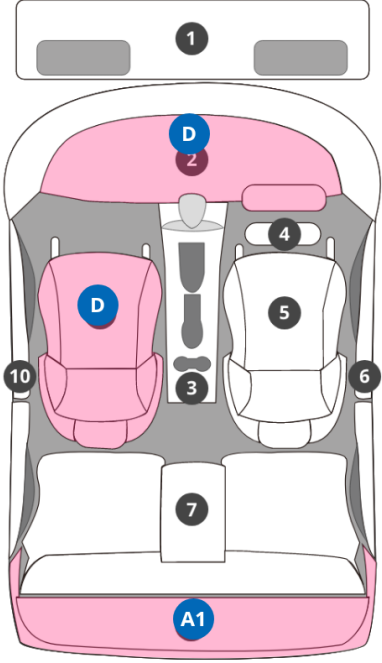
| <b>Interior Evaluation :</b> <span style="color: red; font-weight: bold;">B</span> | <b>Exterior Evaluation :</b> <span style="color: red; font-weight: bold;">C</span> |
| <b>Remarks</b><br>(L) Front Seat - Worn - Yes / Dashboard - Traces of Adhesive Tape - Yes / Trunk Room - Worn, Scratch, Cut, Crack - Minimal | <b>Remarks</b><br>Bonnet, Headlight - Scratch - Small / Front Bumper, Grille, Lamps - Scratch - Medium / (R) Step, In-panel, Side Spoiler - Scratch & Dent - Small / (R) Rear Fender, Molding - Scratch - Small / (R) Rear Door, Molding - Scratch - Large / Trunk Hood, Rear Gate - Dent - Minimal / Rear Bumper, Lamps, Panels - Scratch - Medium / (L) Front Door, Molding - Scratch - Medium / (L) Rear Fender, Molding - Scratch - Minimal / (L) Mirror - Scratch, Peeled - Minimal |
