## General Information

| Make | Mitsubishi | Model | Mirage |
| YOM | 2020 | Odo Meter Reading | 63,951 |
| Registration No. | GAU1365 | Chassis No. | PAEA13MJLLA011461 |

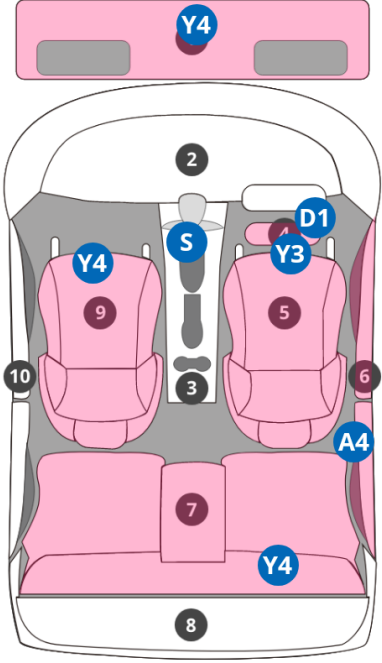
| Interior Evaluation : <b>C</b> | Exterior Evaluation : <b>B</b> |
|---|---|
| <p><b>Remarks</b></p> <p>Overall Interior - Smell - Yes / (R) Front Seat - Grime - Medium / Rear Seat - Grime - Large / Carpet - Worked - Minimal / (L) Front Seat - Grime - Large / Ceiling - Grime - Large / (R) Rear Trim - Cut, Crack - Large</p> | <p><b>Remarks</b></p> <p>(R) Rear Door - Repair Traces - Yes / (R) Mirror - Scratch, Peeled - Minimal / (R) Rear Door, Molding - Scratch - Small / Rear Bumper, Lamps, Panels - Scratch - Small / Trunk Hood, Rear Gate - Scratch - Minimal / (L) Front Door, Molding - Scratch - Small / Front Bumper, Grille, Lamps - Scratch - Small</p> |
