## General Information

| Make | Isuzu | Model | D-MAX |
| Registration No. | FAM4594 | Chassis No. | PABTFR86DF2000983 |

## Body / Panel Condition

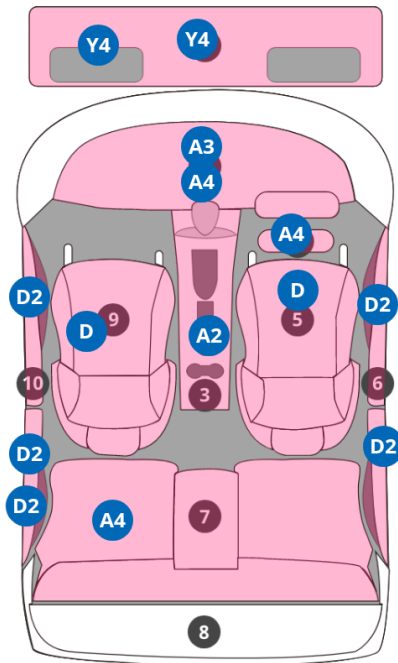
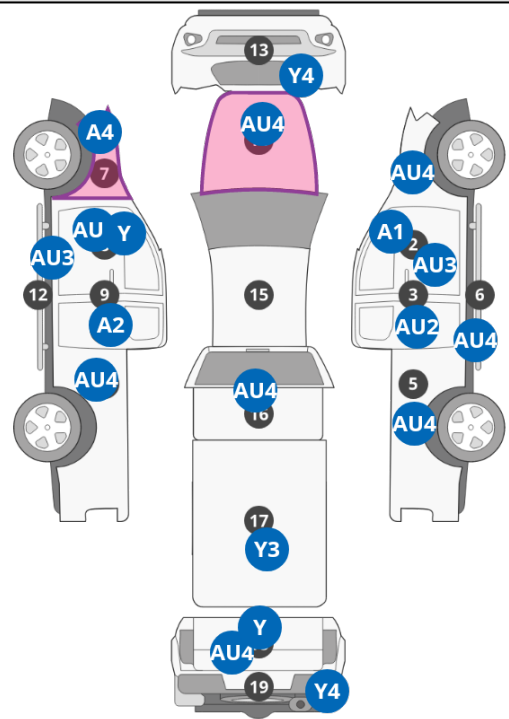
| Interior Evaluation : <span>E</span> | Exterior Evaluation : <span>E</span> |
| <b>Remarks</b><br>Overall Interior - Worn as per age - Yes / Ceiling - Grime - Large / Sunvisor, Sunglass Holder - Grime - Large / Dashboard - Worn, Scratch, Cut, Crack - Medium / Console, Switchs, Vents - Worn, Scratch, Cut, Crack - Small / (R) Front Seat - Worn - Yes / (R) Rear Trim - Worked - Small / (R) Front Trim - Worked - Small / Rear Seat - Cut, Crack - Large / (L) Rear Trim - Worked - Small / (L) Front Trim - Worked - Small / (L) Front Seat - Worn - Yes / Carpet - Worn, Scratch, Cut, Crack - Large / Steering Wheel - Worn, Peel, Crack - Large / Room Mirror - Missing - Yes / Trim Other - Worked - Small | <b>Remarks</b><br>(R) Front Door - Repair Traces - Yes / (R) Front Fender - Repair Traces - Yes / Bonnet - Repair Traces - Yes / (L) Front Fender - Repair Traces - Yes / (L) Front Door - Repair Traces - Yes / (L) Rear Door - Repair Traces - Yes / (L) Rear Corner Panel - Repair Traces - Yes / (R) Rear Door - Repair Traces - Yes / Roof - Repair Traces - Yes / Overall Exterior - Worn as per age - Yes / (R) Front Fender, Molding - Scratch & Dent - Large / (R) Mirror - Scratch - Minimal / (R) Front Door, Molding - Scratch & Dent - Medium / (R) Step, In-panel, Side Spoiler - Scratch & Dent - Large / (R) Rear Door, Molding - Scratch & Dent - Small / (R) Side Gate - Scratch & Dent - Large / Rear Bumper, Lamps, Panels - Crack, Gap - Large / Rear Gate - Scratch & Dent - Large / Cargo Bed Floor - Crack, Gap - Medium / (L) Side Gate - Scratch & Dent - Large / (L) Rear Door, Molding - Scratch - Small / (L) Front Door, Molding - Scratch & Dent - Medium / (L) Step, In-panel, Side Spoiler - Scratch & Dent - Medium / (L) Front Fender, Molding - Repair mark - Difference in Color / (L) Front Fender, Molding - Scratch - Large / Front Bumper, Grille, Lamps - Crack, Gap - Large / Bonnet, Headlight - Repair mark - Difference in Color / Bonnet, Headlight - Scratch & Dent - Large / Roof - Scratch & Dent - Large / (L) Mirror - Crack - Damaged / Antennae - Damaged - Yes |
