## General Information

| Make | Toyota | Model | Vios |
| YOM | 2024 | Mileage | 10,115 |
| Registration No. | VAB8355 | Chassis No. | PA1B18F34R4258845 |

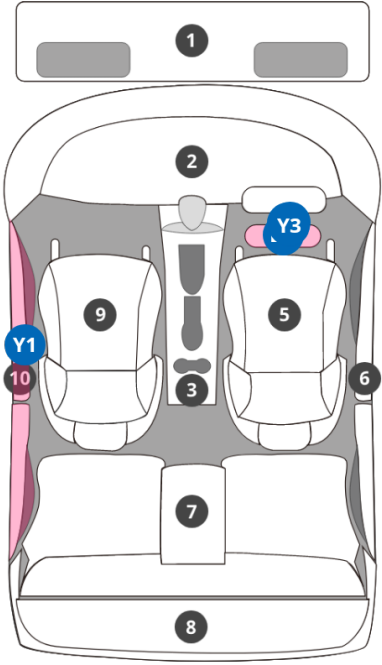
| Interior Evaluation : <b>B</b> | Exterior Evaluation : <b>C</b> |
| <p><b>Remarks</b><br/>Mat Other - Grime - Medium / (R) Front Floor Mat - Grime - Medium / (L) Front Floor Mat - Worked - Small / (L) Front Floor Mat - Grime - Medium / (L) Front Trim - Grime - Minimal</p> | <p><b>Remarks</b><br/>(R) Rear Fender, Molding - Scratch - Minimal / Rear Bumper, Lamps, Panels - Scratch - Large / Trunk Hood, Rear Gate - Scratch - Minimal / (L) Front Fender, Molding - Scratch - Small / (L) Front Door, Molding - Scratch - Small / Front Bumper, Grille, Lamps - Scratch - Medium</p> |
