## General Information

| Make | Toyota | Model | Rush |
| Registration No. | CAV1219 | Chassis No. | MHKE8FF3PLK022414 |

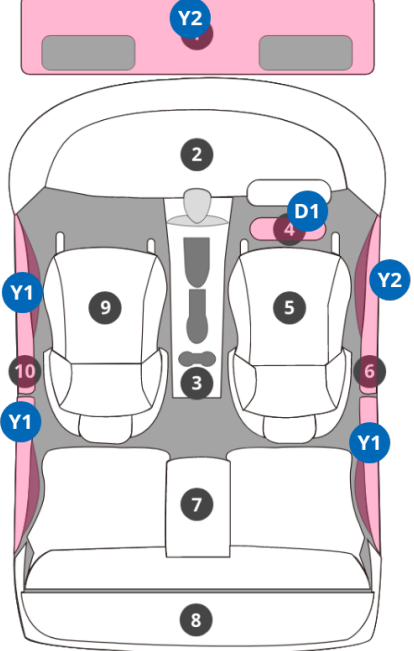
| Interior Evaluation : <b>A</b> | Exterior Evaluation : <b>E</b> |
| <p><b>Remarks</b><br/>Ceiling - Grime - Small / (L) Front Trim - Grime - Minimal / (L) Rear Trim - Grime - Minimal / (R) Front Trim - Grime - Small / Carpet - Worked - Minimal / (R) Rear Trim - Grime - Minimal</p> | <p><b>Remarks</b><br/>(R) Front Fender, Molding - Scratch - Medium / (R) Mirror - Scratch - Minimal / (R) Front Door, Molding - Scratch &amp; Dent - Medium / (R) Step, In-panel, Side Spoiler - Scratch &amp; Dent - Small / (R) Rear Door, Molding - Repair mark - Yes / (R) Rear Door, Molding - Scratch - Large / (R) Rear Fender, Molding - Scratch &amp; Dent - Minimal / Rear Bumper, Lamps, Panels - Scratch &amp; Dent - Large / Trunk Hood, Rear Gate - Scratch - Small / (L) Rear Fender, Molding - Scratch - Minimal / (L) Rear Door, Molding - Scratch &amp; Dent - Small / (L) Front Door, Molding - Scratch - Small / (L) Mirror - Scratch - Minimal / Roof - Scratch - Minimal / (L) Front Fender, Molding - Scratch - Small / Front Bumper, Grille, Lamps - Scratch - Large / Bonnet, Headlight - Scratch &amp; Dent - Minimal</p> |
