## General Information

| Make | Toyota | Model | Avanza |
| Registration No. | NEA3137 | Chassis No. | MHKM5FE3FKK002528 |

## Body / Panel Condition

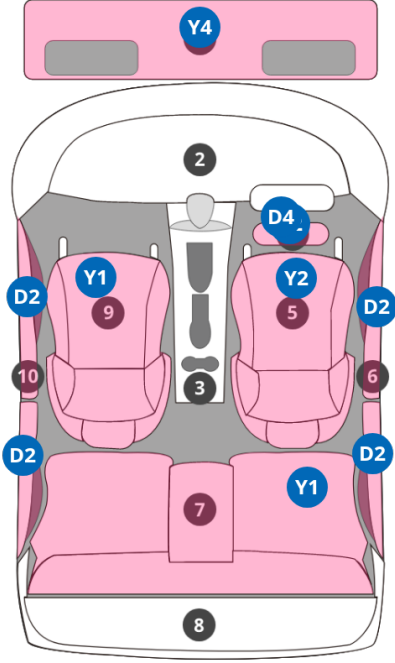
| Interior Evaluation : <b>C</b> | Exterior Evaluation : <b>E</b> |
|---|---|
| <p><b>a</b> : Cut, Fray <b>d</b> : Loose, Deformed <b>k</b> : Animal Hair <b>s</b> : Smell <b>t</b> : Cigarette Burns <b>x</b> : Defective <b>y</b> : Stain</p> | <p><b>A</b> : Scratch <b>AU</b> : Scratch &amp; Dent <b>B</b> : Modified <b>C</b> : Corrosion <b>G</b> : Stone chip <b>P</b> : Faded <b>S</b> : Rust <b>SC</b> : Rust &amp; Corrosion <b>U</b> : Dent <b>X</b> : Defective <b>Y</b> : Crack, Gap</p> |
| <p><b>Remarks</b></p> <p>Ceiling - Grime - Large / Carpet - Worn, Scratch, Cut, Crack - Small / (R) Rear Trim - Worked - Small / Rear Seat - Grime - Minimal / (R) Front Trim - Worked - Small / (R) Front Seat - Grime - Small / (L) Rear Trim - Worked - Small / (L) Front Trim - Worked - Small / (L) Front Floor Mat - Worked - Large / (L) Front Seat - Grime - Minimal</p> | <p><b>Remarks</b></p> <p>(R) Front Fender, Molding - Scratch &amp; Dent - Large / (R) Mirror - Scratch - Medium / (R) Step, In-panel, Side Spoiler - Scratch &amp; Dent - Large / (R) Front Door, Molding - Scratch &amp; Dent - Minimal / (R) Rear Fender, Molding - Scratch &amp; Dent - Large / Trunk Hood, Rear Gate - Scratch &amp; Dent - Minimal / Rear Bumper, Lamps, Panels - Crack, Gap - Medium / (L) Rear Fender, Molding - Scratch &amp; Dent - Medium / (L) Rear Door, Molding - Scratch &amp; Dent - Large / (L) Front Door, Molding - Scratch &amp; Dent - Large / (L) Step, In-panel, Side Spoiler - Scratch &amp; Dent - Medium / Roof - Scratch &amp; Dent - Minimal / (L) Mirror - Scratch - Minimal / (L) Front Fender, Molding - Scratch &amp; Dent - Medium / Front Bumper, Grille, Lamps - Scratch - Medium / Bonnet, Headlight - Scratch - Minimal / Front Windshield - Scratch, Stone chip - Small</p> |
