## General Information

| Make | Toyota | Model | Wigo |
| Registration No. | NHF3388 | Chassis No. | MHKAA4DE4FNJ005275 |

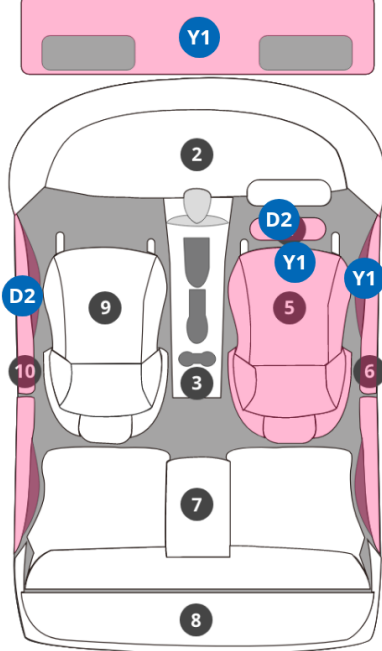
| Interior Evaluation : <b>A</b> | Exterior Evaluation : <b>C</b> |
|---|---|
| <p><b>Remarks</b><br/>Ceiling - Grime - Minimal / (R) Front Trim - Grime - Minimal / (R) Front Seat - Grime - Minimal / (L) Front Trim - Worked - Small / (L) Front Floor Mat - Worked - Small</p> | <p><b>Remarks</b><br/>Bonnet - Repair Traces - Yes / (R) Front Fender, Molding - Scratch - Minimal / (R) Mirror - Scratch - Minimal / (R) Front Door, Molding - Scratch - Small / (R) Step, In-panel, Side Spoiler - Scratch - Minimal / (R) Rear Door, Molding - Scratch &amp; Dent - Large / (R) Rear Fender, Molding - Scratch - Minimal / Rear Bumper, Lamps, Panels - Scratch - Medium / Trunk Hood, Rear Gate - Scratch - Minimal / (L) Rear Fender, Molding - Scratch - Minimal / (L) Rear Door, Molding - Scratch &amp; Dent - Minimal / (L) Front Door, Molding - Scratch - Minimal / (L) Mirror - Scratch - Minimal / (L) Step, In-panel, Side Spoiler - Scratch - Minimal / (L) Front Fender, Molding - Scratch - Small / Front Bumper, Grille, Lamps - Scratch &amp; Dent - Large / Bonnet, Headlight - Scratch &amp; Dent - Minimal</p> |

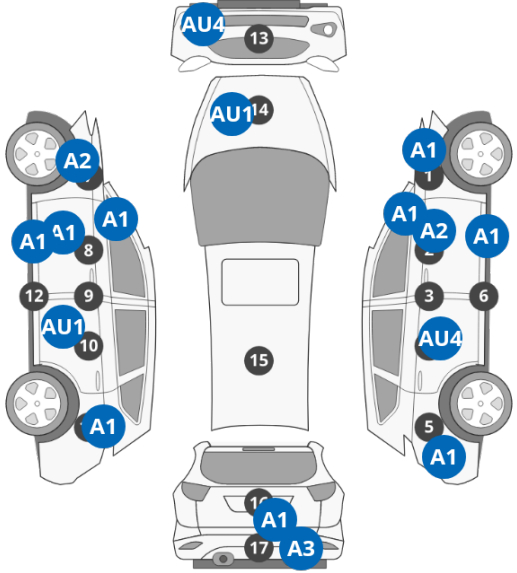
| Inspector Notes |
|---|
| With Lto plate,with spare tire and jack, 2keys, no warranty booklet and tools, scratches on headlights and taillights, |
