## General Information

| Make | Toyota | Model | Vios |
| Registration No. | NFE5531 | Chassis No. | PA1B18F38N4185621 |

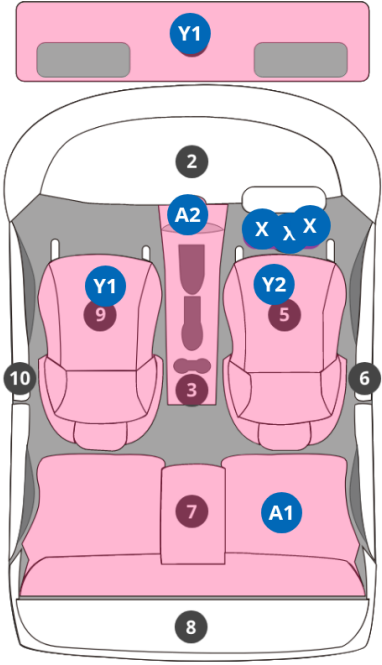
| Interior Evaluation : <b>B</b> | Exterior Evaluation : <b>E</b> |
|---|---|
| <b>Remarks</b><br>Ceiling - Grime - Minimal / Rear Seat - Cut, Crack - Minimal / Mat Other - Missing - Yes / (R) Front Floor Mat - Missing - Yes / (R) Front Seat - Grime - Small / (L) Front Seat - Grime - Minimal / (L) Front Floor Mat - Missing - Yes / Console, Switchs, Vents - Worn, Scratch, Cut, Crack - Small | <b>Remarks</b><br>(L) Front Fender - Repair Traces - Yes / (R) Front Fender, Molding - Scratch & Dent - Medium / (R) Step, In-panel, Side Spoiler - Scratch & Dent - Large / (R) Mirror - Scratch - Minimal / (R) Front Door, Molding - Scratch & Dent - Medium / (R) Rear Door, Molding - Scratch - Small / (R) Rear Fender, Molding - Scratch & Dent - Medium / Rear Bumper, Lamps, Panels - Scratch & Dent - Large / Trunk Hood, Rear Gate - Scratch & Dent - Minimal / (L) Rear Fender, Molding - Scratch - Minimal / (L) Rear Door, Molding - Scratch & Dent - Minimal / (L) Step, In-panel, Side Spoiler - Scratch & Dent - Small / (L) Front Door, Molding - Scratch & Dent - Medium / Roof - Scratch - Minimal / (L) Front Fender, Molding - Scratch - Minimal / Front Bumper, Grille, Lamps - Scratch & Dent - Large / Bonnet, Headlight - Scratch & Dent - Medium / (L) Mirror - Scratch - Minimal / (L) Mirror - Crack - Damaged |

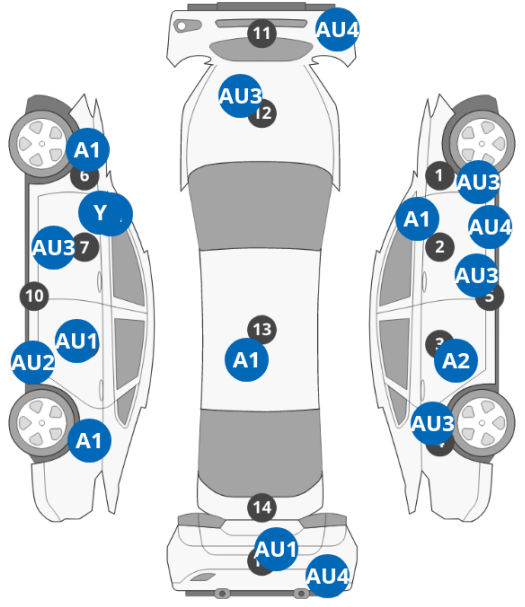
| Inspector Notes |
|---|
| With Lto plate, with spare tire, 2keys, no warranty booklet and tools and Jack, scratches on headlights and taillights, traction control lamp on, airbag warning lamp on, ABS warning lamp on, possible flooding, abnormal sound on engine |
