## General Information

| Make | Toyota | Model | Vios |
| Registration No. | CBD7515 | Chassis No. | PA1B18F39N4185028 |

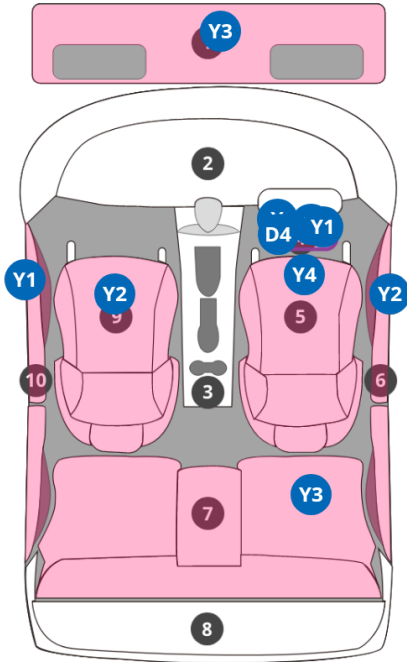
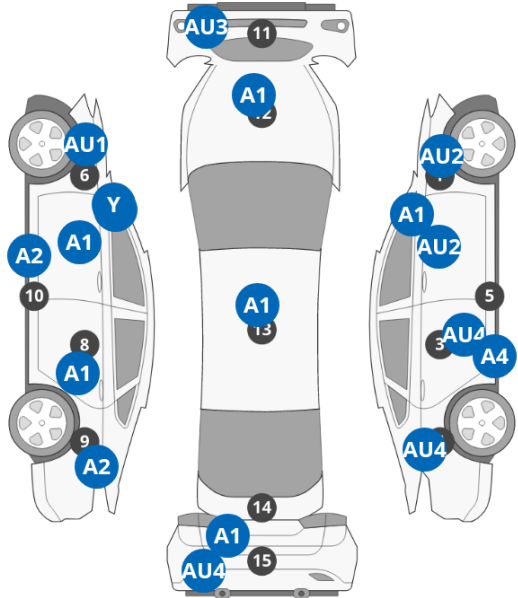
| Interior Evaluation : <b>C</b> | Exterior Evaluation : <b>E</b> |
|---|---|
| <p><b>a</b> : Cut, Fray <b>d</b> : Loose, Deformed <b>k</b> : Animal Hair <b>s</b> : Smell <b>t</b> : Cigarette Burns <b>x</b> : Defective <b>y</b> : Stain</p> | <p><b>A</b> : Scratch <b>AU</b> : Scratch &amp; Dent <b>B</b> : Modified <b>C</b> : Corrosion <b>G</b> : Stone chip <b>P</b> : Faded <b>S</b> : Rust <b>SC</b> : Rust &amp; Corrosion <b>U</b> : Dent <b>X</b> : Defective <b>Y</b> : Crack, Gap</p> |
| <p><b>Remarks</b></p> <p>Ceiling - Grime - Medium / Rear Seat - Grime - Medium / (R) Front Trim - Grime - Small / (L) Front Trim - Grime - Minimal / (R) Front Seat - Grime - Large / (L) Front Seat - Grime - Small / (R) Front Floor Mat - Missing - Yes / (L) Front Floor Mat - Missing - Yes / Mat Other - Grime - Minimal / Carpet - Worked - Large</p> | <p><b>Remarks</b></p> <p>(R) Front Fender, Molding - Scratch &amp; Dent - Small / (R) Mirror - Scratch - Minimal / (R) Front Door, Molding - Scratch &amp; Dent - Small / (R) Rear Door, Molding - Scratch &amp; Dent - Large / (R) Step, In-panel, Side Spoiler - Scratch - Large / (R) Rear Fender, Molding - Scratch &amp; Dent - Large / Rear Bumper, Lamps, Panels - Scratch &amp; Dent - Large / Trunk Hood, Rear Gate - Scratch - Minimal / (L) Rear Fender, Molding - Scratch - Small / (L) Rear Door, Molding - Scratch - Minimal / (L) Front Door, Molding - Scratch - Minimal / (L) Step, In-panel, Side Spoiler - Scratch - Small / Roof - Scratch - Minimal / (L) Mirror - Scratch - Minimal / (L) Front Fender, Molding - Scratch &amp; Dent - Minimal / Front Bumper, Grille, Lamps - Scratch &amp; Dent - Medium / Bonnet, Headlight - Scratch - Minimal / (L) Mirror - Crack - Damaged</p> |
