## General Information

| Make | Toyota | Model | Vios |
| YOM | 2024 | Mileage | 11,218 |

## Body / Panel Condition

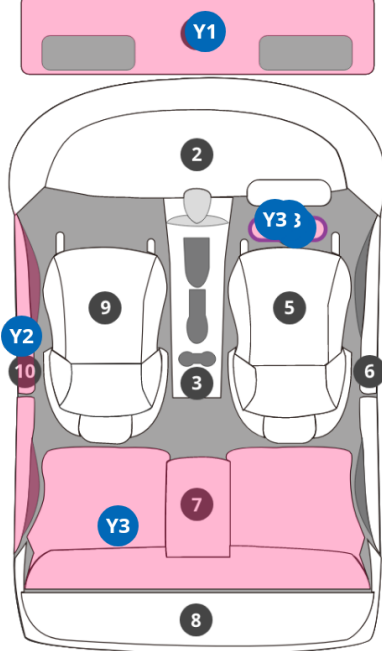
| Interior Evaluation : <b>B</b> | Exterior Evaluation : <b>D</b> |
| <p><b>Remarks</b></p> <p>Mat Other - Missing - Yes / (R) Front Floor Mat - Grime - Medium / (L) Front Floor Mat - Grime - Medium / Rear Seat - Grime - Medium / (L) Front Trim - Grime - Small / Ceiling - Grime - Minimal</p> | <p><b>Remarks</b></p> <p>(R) Front Fender, Molding - Scratch &amp; Dent - Minimal / (R) Front Door, Molding - Scratch &amp; Dent - Small / (R) Rear Door, Molding - Scratch - Medium / Trunk Hood, Rear Gate - Scratch - Medium / Rear Bumper, Lamps, Panels - Scratch - Medium / (L) Rear Fender, Molding - Dent - Small / (L) Rear Door, Molding - Scratch - Small / (L) Front Door, Molding - Scratch - Small / (L) Front Fender, Molding - Scratch - Small / Bonnet, Headlight - Scratch - Medium / Front Bumper, Grille, Lamps - Scratch - Small / Roof - Scratch - Small</p> |
