## General Information

| Make | Toyota | Model | Vios |
| YOM | 2024 | Mileage | 10,971 |
| Registration No. | NHE8092 | Chassis No. | PA1B18F30P4231879 |

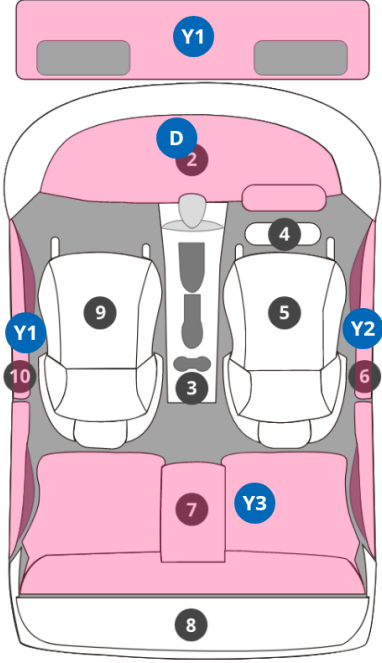
| Interior Evaluation : <b>B</b> | Exterior Evaluation : <b>C</b> |
| <p><b>Remarks</b><br/>Rear Seat - Grime - Medium / Dashboard - Traces of Adhesive Tape - Yes / (L) Front Trim - Grime - Minimal / (R) Front Trim - Grime - Small / Ceiling - Grime - Minimal</p> | <p><b>Remarks</b><br/>(L) Front Fender - Repair Traces - Yes / (R) Mirror - Scratch - Minimal / (R) Front Door, Molding - Scratch &amp; Dent - Medium / (R) Rear Door, Molding - Scratch &amp; Dent - Medium / (R) Rear Fender, Molding - Scratch &amp; Dent - Small / Rear Bumper, Lamps, Panels - Scratch - Medium / (L) Rear Door, Molding - Dent - Minimal / Front Bumper, Grille, Lamps - Scratch - Medium</p> |
