## General Information

| Make | Toyota | Model | Wigo |

## Body / Panel Condition

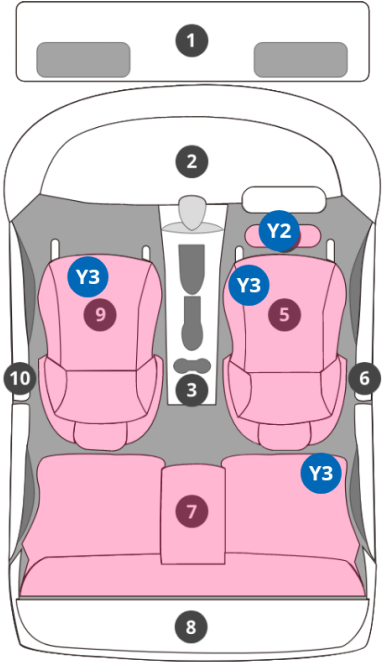
| Interior Evaluation : <b>B</b> | Exterior Evaluation : <b>B</b> |
|---|---|
| <p><b>Remarks</b><br/>(R) Front Seat - Grime - Medium / Rear Seat - Grime - Medium / Mat Other - Grime - Small / (L) Front Seat - Grime - Medium</p> | <p><b>Remarks</b><br/>(L) Front Fender, Molding - Scratch - Small / Front Bumper, Grille, Lamps - Scratch &amp; Dent - Medium / (L) Front Door, Molding - Scratch &amp; Dent - Small / (R) Front Door, Molding - Scratch - Medium / Rear Bumper, Lamps, Panels - Scratch - Small / (L) Step, In-panel, Side Spoiler - Dent - Small</p> |
