## General Information

| Make | Toyota | Model | Wigo |
| Registration No. | NFE7010 | Chassis No. | MHKA4DF5FNJ071450 |

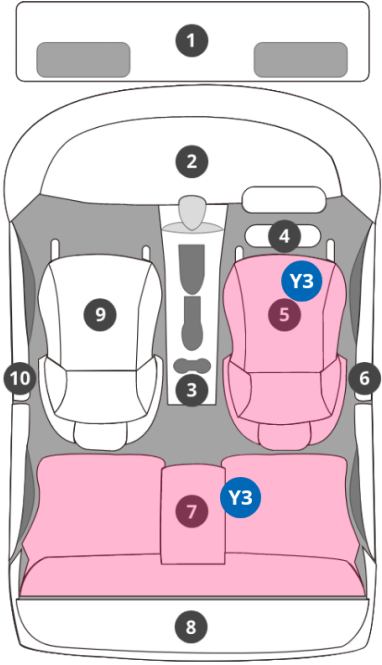
| Interior Evaluation : <b>B</b> | Exterior Evaluation : <b>D</b> |
|---|---|
| <b>Remarks</b><br>Rear Seat - Grime - Medium / (R) Front Seat - Grime - Medium | <b>Remarks</b><br>Front Bumper, Grille, Lamps - Scratch & Dent - Large / (R) Front Door, Molding - Scratch & Dent - Medium / (R) Rear Door, Molding - Scratch & Dent - Minimal / (R) Rear Fender, Molding - Scratch - Medium / Rear Bumper, Lamps, Panels - Crack, Gap - Large / Trunk Hood, Rear Gate - Scratch - Medium / (L) Rear Fender, Molding - Scratch - Small / (L) Rear Door, Molding - Scratch - Small / (L) Front Door, Molding - Scratch - Small / (L) Front Fender, Molding - Scratch & Dent - Medium |
