## General Information

| Make | Toyota | Model | Wigo |

## Body / Panel Condition

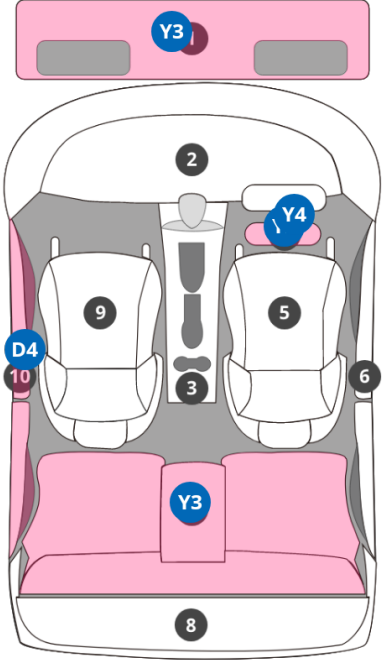
| Interior Evaluation : <b>C</b> | Exterior Evaluation : <b>C</b> |
| <p><b>Remarks</b><br/>Mat Other - Grime - Small / Rear Seat - Grime - Medium / (R) Front Floor Mat - Grime - Large / (L) Front Trim - Worked - Large / Ceiling - Grime - Medium</p> | <p><b>Remarks</b><br/>(R) Mirror - Scratch - Minimal / (R) Front Door, Molding - Scratch - Small / (R) Rear Fender, Molding - Scratch - Small / Rear Bumper, Lamps, Panels - Scratch - Medium / (L) Rear Fender, Molding - Scratch &amp; Dent - Small / (L) Rear Door, Molding - Scratch &amp; Dent - Minimal / (L) Front Door, Molding - Scratch - Minimal / (L) Front Fender, Molding - Scratch - Small / Front Bumper, Grille, Lamps - Scratch - Small / Bonnet, Headlight - Scratch &amp; Dent - Small / (L) Mirror - Scratch - Small</p> |
