## General Information

| Make | Toyota | Model | Wigo |
| YOM | 2021 | Mileage | 59,225 |
| Registration No. | NDZ5393 | Chassis No. | MHKA4DF5FMJ054787 |

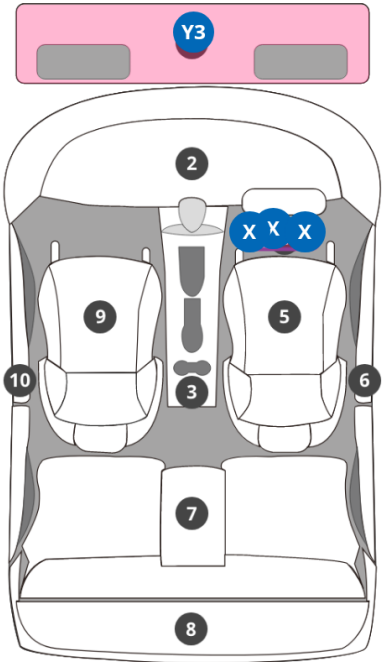
| <b>Interior Evaluation :</b> <span style="color: red; font-weight: bold;">B</span> | <b>Exterior Evaluation :</b> <span style="color: red; font-weight: bold;">C</span> |
| <b>Remarks</b><br>Mat Other - Missing - Yes / (R) Front Floor Mat - Missing - Yes / (L) Front Floor Mat - Missing - Yes / Ceiling - Grime - Medium | <b>Remarks</b><br>(R) Rear Door, Molding - Scratch & Dent - Minimal / (R) Front Fender, Molding - Scratch & Dent - Small / (R) Mirror - Scratch - Medium / (R) Step, In-panel, Side Spoiler - Scratch & Dent - Large / (R) Rear Fender, Molding - Scratch & Dent - Minimal / (L) Mirror - Scratch - Small / Front Bumper, Grille, Lamps - Scratch - Medium / Rear Bumper, Lamps, Panels - Crack, Gap - Medium / (L) Center Panel - Scratch - Small / (L) Front Fender, Molding - Dent - Small |
