## General Information

| Make | Toyota | Model | Vios |

## Body / Panel Condition

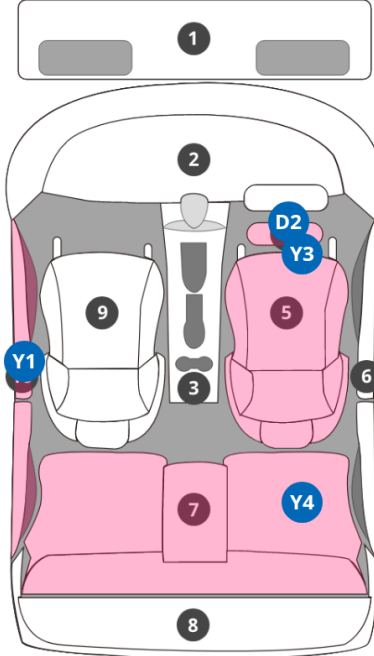
| Interior Evaluation : <span style="color: red;">C</span> | Exterior Evaluation : <span style="color: red;">C</span> |
| <p><b>Remarks</b></p> <p>Rear Seat - Grime - Large / (R) Front Seat - Grime - Medium / (L) Front Floor Mat - Worked - Small / (L) Front Trim - Grime - Minimal</p> | <p><b>Remarks</b></p> <p>(R) Front Door, Molding - Scratch - Large / Rear Bumper, Lamps, Panels - Scratch - Large / Trunk Hood, Rear Gate - Dent - Small / (R) Front Fender, Molding - Scratch - Small / (L) Front Fender, Molding - Scratch - Medium / Front Bumper, Grille, Lamps - Scratch - Small / (L) Rear Fender, Molding - Scratch - Small</p> |
