## General Information

| Make | Toyota | Model | Vios |

## Body / Panel Condition

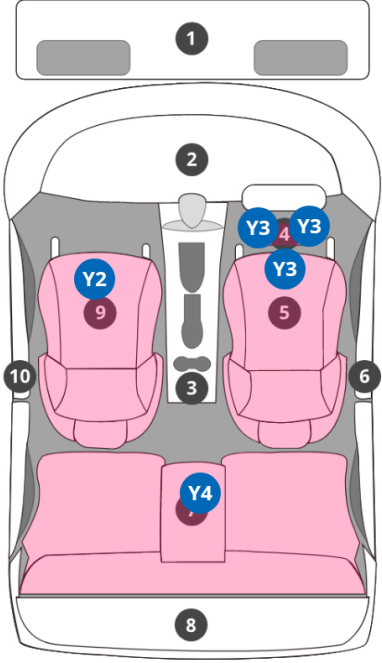
| Interior Evaluation : <span style="color: red;">C</span> | Exterior Evaluation : <span style="color: red;">D</span> |
| <p><b>Remarks</b><br/>(R) Front Seat - Grime - Medium / (R) Front Floor Mat - Grime - Medium / (L) Front Floor Mat - Grime - Medium / (L) Front Seat - Grime - Small / Rear Seat - Grime - Large</p> | <p><b>Remarks</b><br/>(R) Rear Door, Molding - Dent - Small / (L) Front Fender, Molding - Dent - Medium / (L) Front Door, Molding - Scratch &amp; Dent - Large / (L) Rear Door, Molding - Scratch &amp; Dent - Small / Bonnet, Headlight - Scratch &amp; Dent - Small / Front Bumper, Grille, Lamps - Scratch &amp; Dent - Large / Rear Bumper, Lamps, Panels - Scratch &amp; Dent - Medium / (R) Front Door, Molding - Scratch - Minimal / Trunk Hood, Rear Gate - Crack, Gap - Large</p> |

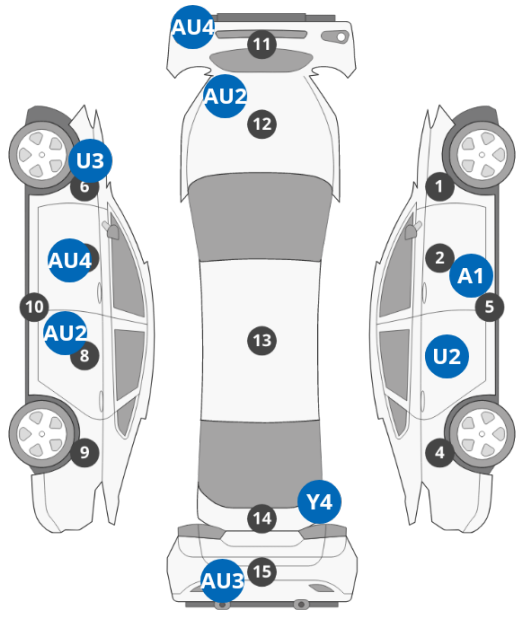
| Inspector Notes |
|---|
| crack left taillight. with warranty booklet. without spare tire, jack and tools. without LTO plate. |
