## General Information

| Make | Toyota | Model | Vios |

## Body / Panel Condition

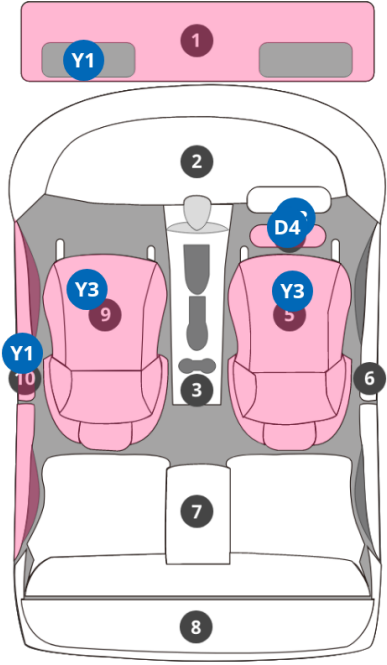
| Interior Evaluation : <b>C</b> | Exterior Evaluation : <b>B</b> |
|---|---|
| <p><b>Remarks</b><br/>(R) Front Seat - Grime - Medium / (L) Front Seat - Grime - Medium / (L) Front Floor Mat - Cut, Crack - Medium / (L) Front Floor Mat - Worked - Large / (L) Front Trim - Grime - Minimal / Ceiling - Grime - Minimal</p> | <p><b>Remarks</b><br/>(R) Front Fender, Molding - Scratch &amp; Dent - Small / (R) Step, In-panel, Side Spoiler - Scratch - Small / (R) Rear Door, Molding - Scratch - Minimal / (R) Rear Fender, Molding - Scratch - Small / Rear Bumper, Lamps, Panels - Scratch - Small / (L) Front Door, Molding - Scratch - Medium / Front Bumper, Grille, Lamps - Scratch - Medium</p> |
