## General Information

| Make | Toyota | Model | Veloz |

## Body / Panel Condition

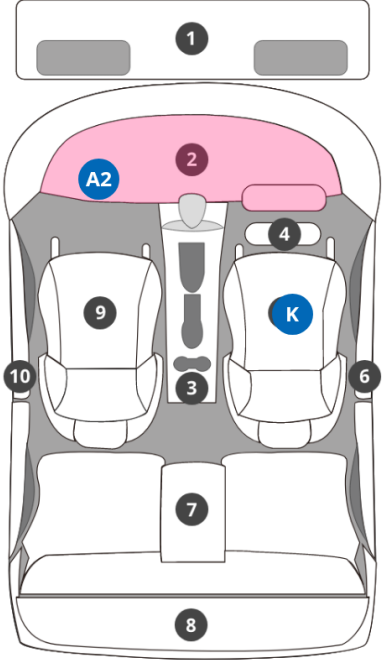
| Interior Evaluation : <b>B</b> | Exterior Evaluation : <b>B</b> |
|---|---|
| <b>Remarks</b><br>Overall Interior - Animal Hair - Yes / Steering Wheel - Worn, Peel, Crack - Small | <b>Remarks</b><br>Front Bumper, Grille, Lamps - Scratch - Small / Bonnet, Headlight - Dent - Small / Trunk Hood, Rear Gate - Scratch & Dent - Small / Rear Bumper, Lamps, Panels - Scratch & Dent - Small / (R) Step, In-panel, Side Spoiler - Scratch & Dent - Medium / Roof - Dent - Small / (L) Rear Fender, Molding - Dent - Small |
