## General Information

| Make | Toyota | Model | Vios |
| YOM | 2024 | Mileage | 13,771 |

## Body / Panel Condition

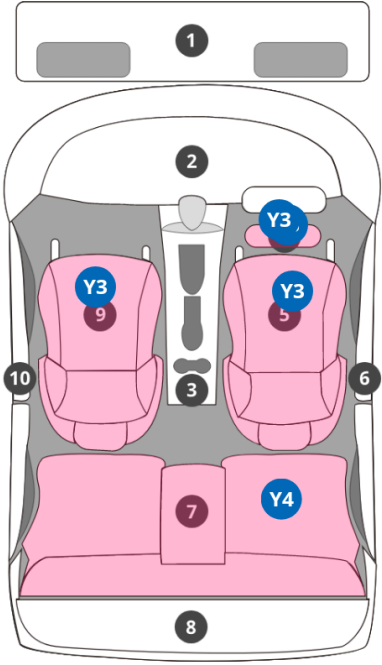
| Interior Evaluation : <b>C</b> | Exterior Evaluation : <b>E</b> |
| <p><b>Remarks</b><br/>(L) Front Floor Mat - Grime - Medium / (R) Front Floor Mat - Grime - Medium / Rear Seat - Grime - Large / (R) Front Seat - Grime - Medium / (L) Front Seat - Grime - Medium</p> | <p><b>Remarks</b><br/>(L) Rear Fender, Molding - Dent - Minimal / Rear Bumper, Lamps, Panels - Scratch - Medium / (L) Rear Door, Molding - Scratch - Large / (L) Front Door, Molding - Scratch - Large / (L) Front Fender, Molding - Scratch - Medium / Bonnet, Headlight - Scratch - Medium / Front Bumper, Grille, Lamps - Scratch - Medium / (R) Front Door, Molding - Scratch - Small / (R) Rear Door, Molding - Scratch - Large / Roof - Scratch - Medium / Trunk Hood, Rear Gate - Scratch - Minimal / (R) Mirror - Scratch, Peeled - Minimal</p> |

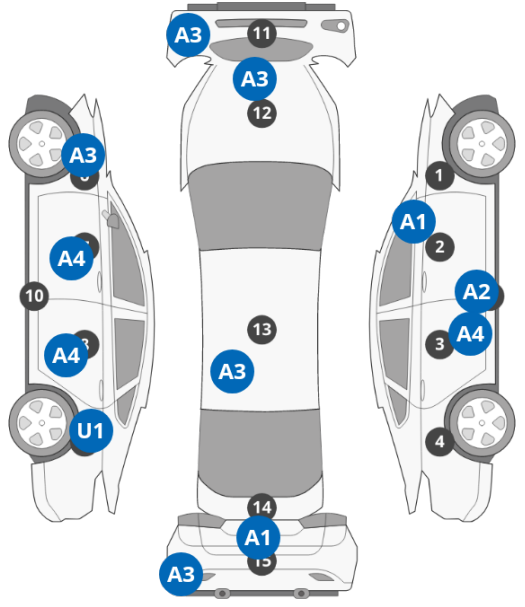
with LTO plate/with spare tire/jack and incomplete tools/Without warranty booklet/ hairlines around the vehicle
