## General Information

| Make | Toyota | Model | Vios |
| YOM | 2024 | Mileage | 15,017 |

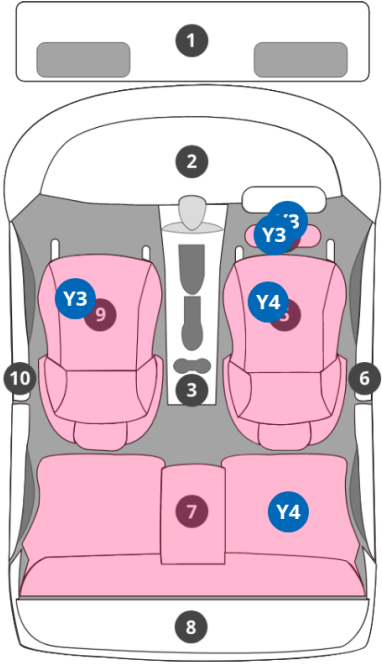
| Interior Evaluation : <span style="color: red;">C</span> | Exterior Evaluation : <span style="color: red;">C</span> |
| <b>Remarks</b><br>Mat Other - Grime - Medium / Rear Seat - Grime - Large / (R) Front Floor Mat - Grime - Medium / (R) Front Seat - Grime - Large / (L) Front Seat - Grime - Medium | <b>Remarks</b><br>(R) Front Fender, Molding - Repair mark - Yes / (R) Front Door, Molding - Repair mark - Yes / (R) Front Fender, Molding - Scratch - Small / (R) Front Door, Molding - Scratch - Small / (R) Step, In-panel, Side Spoiler - Scratch - Small / (R) Rear Fender, Molding - Scratch - Minimal / Rear Bumper, Lamps, Panels - Scratch - Small / (L) Rear Fender, Molding - Scratch - Minimal / (L) Mirror - Scratch - Minimal / (L) Front Fender, Molding - Scratch - Small / Front Bumper, Grille, Lamps - Scratch - Small / (L) Front Door, Molding - Scratch - Minimal / (L) Rear Door, Molding - Scratch - Minimal / (R) Rear Door, Molding - Scratch - Minimal |
