## General Information

| Make | Toyota | Model | Vios |
| YOM | 2024 | Mileage | 11,822 |
| Registration No. | DBO4678 | Chassis No. | PA1B18F35P4235099 |

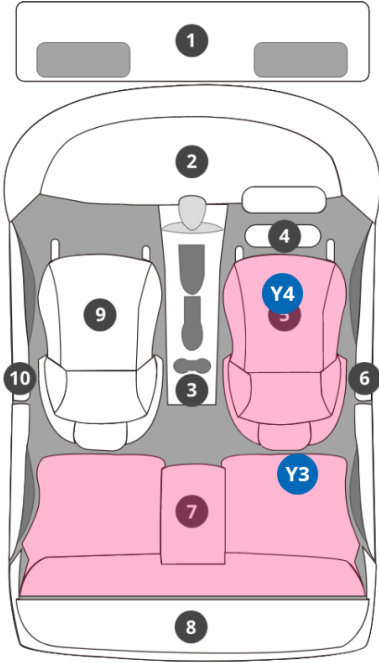
| Interior Evaluation : <span style="color: red; font-weight: bold;">C</span> | Exterior Evaluation : <span style="color: red; font-weight: bold;">B</span> |
|---|---|
| <p><b>Remarks</b><br/>(R) Front Seat - Grime - Large / Rear Seat - Grime - Medium</p> | <p><b>Remarks</b><br/>(R) Front Door, Molding - Scratch - Small / (R) Rear Door, Molding - Dent - Small / (L) Rear Fender, Molding - Scratch - Minimal / Rear Bumper, Lamps, Panels - Scratch - Medium / (L) Front Door, Molding - Scratch - Minimal / Front Bumper, Grille, Lamps - Scratch &amp; Dent - Medium</p> |
