## General Information

| Make | Toyota | Model | Avanza |

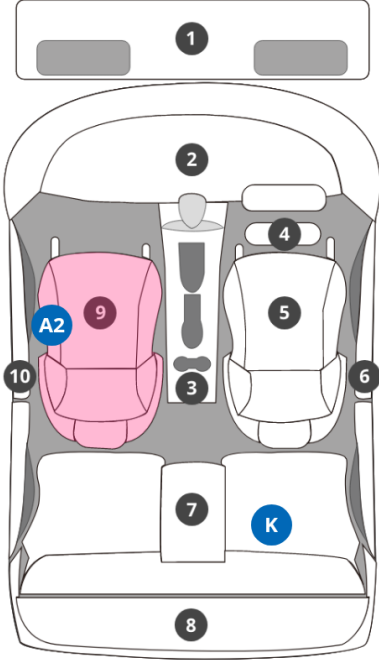
| Interior Evaluation : <b>C</b> | Exterior Evaluation : <b>D</b> |
| <p><b>Remarks</b></p> <p>(L) Front Seat - Cut, Crack - Small / Overall Interior - Animal Hair - Yes / Overall Interior - Worn as per age - Yes</p> | <p><b>Remarks</b></p> <p>Bonnet - Repair Traces - Yes / (L) Front Fender - Repair Traces - Yes / Bonnet, Headlight - Crack, Gap - Large / Front Bumper, Grille, Lamps - Crack, Gap - Large / (L) Front Door, Molding - Scratch - Medium / (L) Rear Door, Molding - Dent - Small / Rear Bumper, Lamps, Panels - Scratch &amp; Dent - Medium / Trunk Hood, Rear Gate - Scratch - Small / (R) Step, In-panel, Side Spoiler - Scratch &amp; Dent - Large / (R) Rear Fender, Molding - Scratch &amp; Dent - Medium / (R) Rear Door, Molding - Dent - Small</p> |
