## General Information

| Make | Toyota | Model | Rush |
| Registration No. | NGC7212 | Chassis No. | MHKE8FF3PPK056739 |

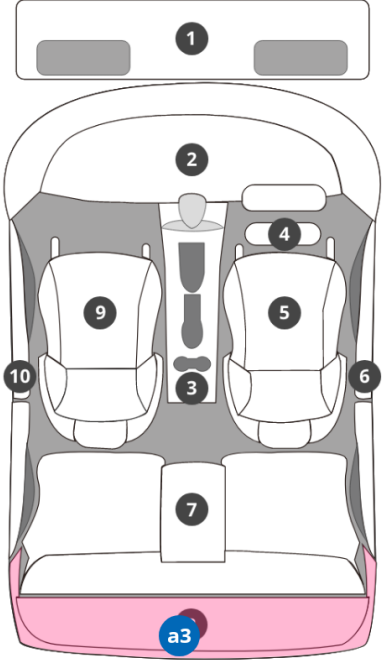
| <b>Remarks</b><br>Trunk Room - Worn, Scratch, Cut, Crack - Medium | <b>Remarks</b><br>(R) Rear Fender, Molding - Scratch & Dent - Large / (L) Rear Door, Molding - Dent - Minimal / (L) Mirror - Scratch, Peeled - Yes / Bonnet, Headlight - Dent - Small / Rear Bumper, Lamps, Panels - Scratch & Dent - Small / Front Bumper, Grille, Lamps - Scratch - Minimal / Trunk Hood, Rear Gate - Scratch - Minimal |
