## General Information

| Make | Lexus | Model | LM |

## Body / Panel Condition

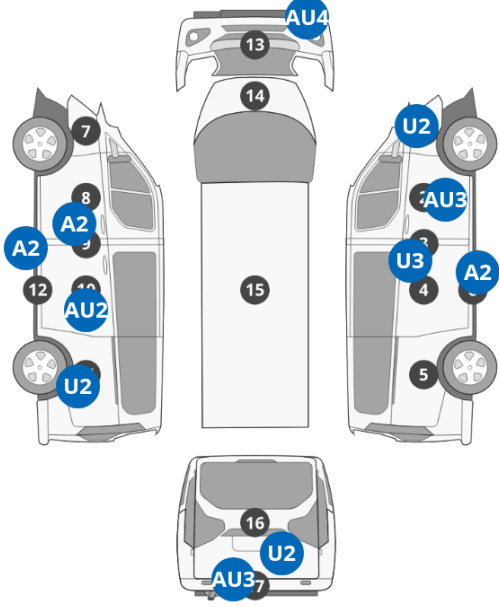
| Interior Evaluation : <span style="color: red;">B</span> | Exterior Evaluation : <span style="color: red;">E</span> |
| <b>Remarks</b><br>(R) Front Seat - Worn - Yes / (L) Front Seat - Worn - Yes / Rear Seat - Worn - Yes | <b>Remarks</b><br>Front Bumper, Grille, Lamps - Scratch & Dent - Large / Rear Bumper, Lamps, Panels - Scratch & Dent - Large / (R) Rear Door, Molding - Dent - Medium / (L) Step, In-panel, Side Spoiler - Scratch - Medium / (R) Front Door, Molding - Scratch & Dent - Large / (R) Rear Fender, Molding - Scratch & Dent - Small / (R) Front Fender, Molding - Dent - Small / (L) Front Fender, Molding - Scratch & Dent - Small / (L) Rear Door, Molding - Scratch & Dent - Small / (L) Front Door, Molding - Scratch & Dent - Small / Trunk Hood, Rear Gate - Dent - Small / (L) Rear Fender, Molding - Dent - Small / Front Windshield - Damaged - Large |

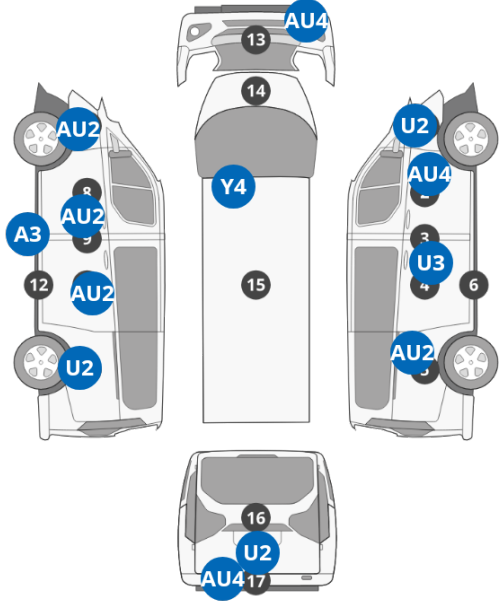
| Inspector Notes |
|---|
| with warranty booklet/ with LTO plate/ with jack and spare tire/ rear door issue / crack on front windshield/ guttermarks on wheels |
