General Information

Date & Time: 19, Mar, 2025 14:25

Make	Toyota	Model	Vios
YOM	2023	Mileage	25,394
Registration No.	NHF7631	Chassis No.	PA1B18F35P4221641
CC	1.3	Transmission	CVT
Fuel Type	Gas	Type of Body	Sedan
Colour	Green

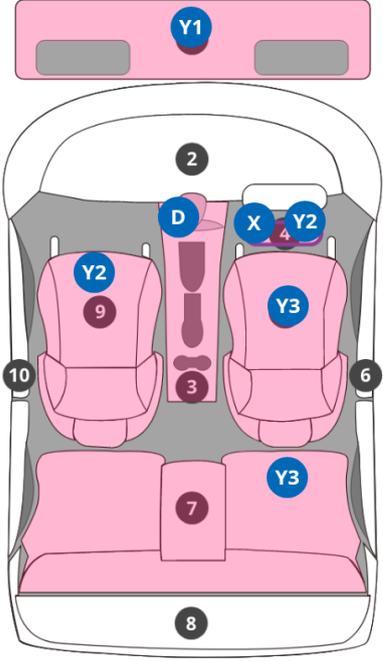
Interior Evaluation : B	Exterior Evaluation : D

<p>a : Cut, Fray d : Loose, Deformed k : Animal Hair s : Smell t : Cigarette Burns x : Defective y : Stain</p>

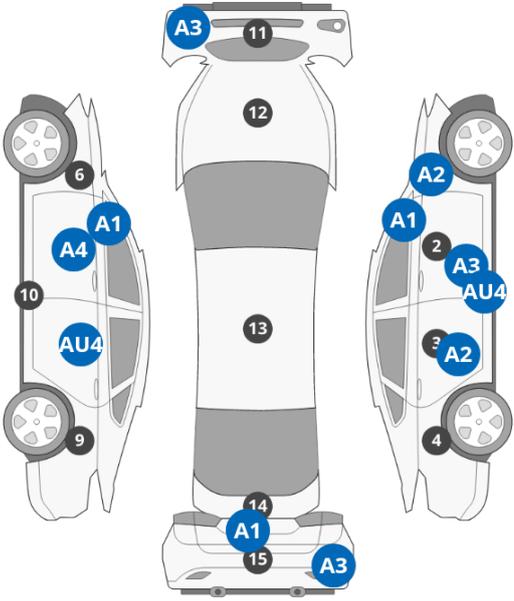
<p>A : Scratch AU : Scratch & Dent B : Modified C : Corrosion G : Stone chip P : Faded S : Rust SC : Rust & Corrosion U : Dent X : Defective Y : Crack, Gap</p>
<p>Remarks Ceiling - Grime - Minimal / (R) Front Seat - Grime - Medium / (R) Front Floor Mat - Grime - Small / (L) Front Floor Mat - Missing - Yes / Rear Seat - Grime - Medium / (L) Front Seat - Grime - Small / Console, Switches, Vents - Traces of Adhesive Tape - Yes</p>	<p>Remarks (R) Front Fender - Repair Traces - Yes / (L) Rear Door, Molding - Scratch & Dent - Large / (L) Front Door, Molding - Scratch - Large / Front Bumper, Grille, Lamps - Scratch - Medium / (R) Mirror - Scratch - Minimal / (R) Front Fender, Molding - Scratch - Small / (R) Rear Door, Molding - Scratch - Small / (R) Front Door, Molding - Scratch - Medium / (R) Step, In-panel, Side Spoiler - Scratch & Dent - Large / Trunk Hood, Rear Gate - Scratch - Minimal / (L) Mirror - Scratch - Minimal / Rear Bumper, Lamps, Panels - Scratch - Medium</p>
