## General Information

| Make | Toyota | Model | Vios |
| YOM | 2021 | Mileage | 36,370 |

## Body / Panel Condition

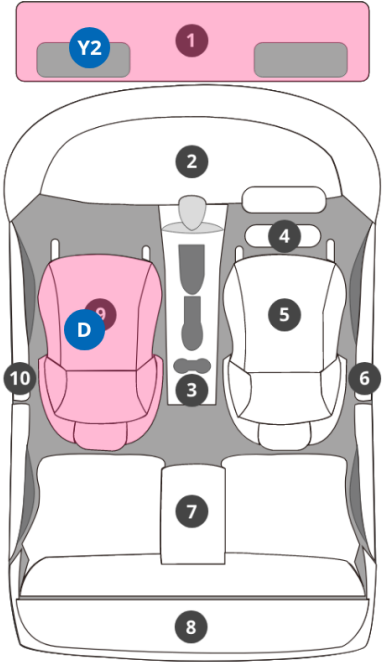
| Interior Evaluation : <span style="color: red;">C</span> | Exterior Evaluation : <span style="color: red;">C</span> |
|---|---|
| <b>Remarks</b><br>(L) Front Seat - Worn - Yes / Ceiling - Grime - Small /<br>Overall Interior - Worn as per age - Yes | <b>Remarks</b><br>(R) Front Fender - Repair Traces - Yes / Bonnet - Repair Traces - Yes /<br>(R) Rear Fender - Repair Traces - Yes / (R) Front Fender, Molding -<br>Repair mark - Yes / (R) Front Door, Molding - Scratch - Minimal / (R)<br>Rear Door, Molding - Dent - Large / Rear Bumper, Lamps, Panels -<br>Scratch - Small / Trunk Hood, Rear Gate - Scratch - Minimal / (R) Rear<br>Fender, Molding - Scratch - Minimal / (L) Rear Fender, Molding -<br>Scratch - Minimal / (L) Rear Door, Molding - Scratch - Minimal / (L)<br>Front Door, Molding - Scratch - Small / (L) Front Fender, Molding -<br>Scratch - Small / Front Bumper, Grille, Lamps - Scratch - Medium /<br>Roof - Rust, Corrosion - Minimal / Bonnet, Headlight - Scratch -<br>Minimal |
