## General Information

| Make | Toyota | Model | Vios |

## Body / Panel Condition

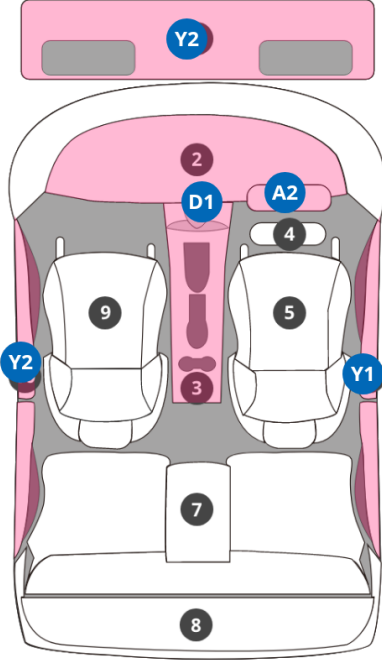
| <p><b>a</b> : Cut, Fray <b>d</b> : Loose, Deformed <b>k</b> : Animal Hair <b>s</b> : Smell <b>t</b> : Cigarette Burns <b>x</b> : Defective <b>y</b> : Stain</p> | <p><b>A</b> : Scratch <b>AU</b> : Scratch &amp; Dent <b>B</b> : Modified <b>C</b> : Corrosion <b>G</b> : Stone chip <b>P</b> : Faded <b>S</b> : Rust <b>SC</b> : Rust &amp; Corrosion <b>U</b> : Dent <b>X</b> : Defective <b>Y</b> : Crack, Gap</p> |
| <b>Remarks</b><br>Ceiling - Grime - Small / (L) Front Trim - Grime - Small / Steering Wheel - Worn, Peel, Crack - Small / Console, Switchs, Vents - Loose, Deformed - Minimal / (R) Front Trim - Grime - Minimal | <b>Remarks</b><br>Bonnet - Repair Traces - Yes / (L) Front Fender - Repair Traces - Yes / (L) Front Door - Repair Traces - Yes / Member (Bolted) - Dent - Yes / Bonnet, Headlight - Repair mark - Yes / (L) Front Fender, Molding - Repair mark - Yes / (R) Front Fender, Molding - Scratch & Dent - Small / (R) Front Door, Molding - Scratch - Medium / (R) Mirror - Scratch - Minimal / (R) Rear Door, Molding - Scratch - Small / Rear Bumper, Lamps, Panels - Scratch & Dent - Small / Trunk Hood, Rear Gate - Scratch - Minimal / (L) Rear Fender, Molding - Scratch - Small / (L) Rear Door, Molding - Scratch - Small / (L) Front Door, Molding - Repair mark - Yes / Roof - Scratch - Medium / (R) Rear Fender, Molding - Scratch - Minimal / Bonnet, Headlight - Rust, Corrosion - Large / (L) Front Fender, Molding - Rust, Corrosion - Large / (L) Front Door, Molding - Dent - Medium |
