## General Information

| Make | Toyota | Model | Vios |
| YOM | 2024 | Mileage | 16,618 |
| Registration No. | NKA1904 | Chassis No. | PA1B18F31R4242697 |

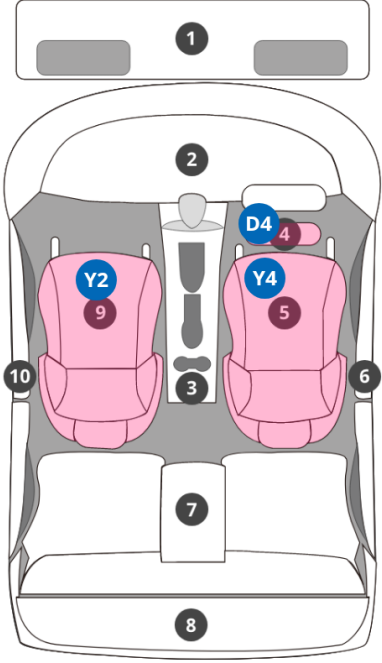
| Interior Evaluation : <b>C</b> | Exterior Evaluation : <b>D</b> |
|---|---|
| <p><b>a</b> : Cut, Fray <b>d</b> : Loose, Deformed <b>k</b> : Animal Hair <b>s</b> : Smell <b>t</b> : Cigarette Burns <b>x</b> : Defective <b>y</b> : Stain</p> | <p><b>A</b> : Scratch <b>AU</b> : Scratch &amp; Dent <b>B</b> : Modified <b>C</b> : Corrosion <b>G</b> : Stone chip <b>P</b> : Faded <b>S</b> : Rust <b>SC</b> : Rust &amp; Corrosion <b>U</b> : Dent <b>X</b> : Defective <b>Y</b> : Crack, Gap</p> |
| <p><b>Remarks</b><br/>(L) Front Seat - Grime - Small / (L) Front Floor Mat - Worked - Large / (R) Front Seat - Grime - Large</p> | <p><b>Remarks</b><br/>Rear Bumper, Lamps, Panels - Scratch - Large / (R) Rear Fender, Molding - Scratch &amp; Dent - Small / (R) Rear Door, Molding - Scratch - Medium / (R) Step, In-panel, Side Spoiler - Scratch &amp; Dent - Large / (R) Front Door, Molding - Scratch - Medium / Front Bumper, Grille, Lamps - Scratch &amp; Dent - Medium / Member (Bolted) - Dent - Yes / (L) Front Fender, Molding - Dent - Small / (L) Front Door, Molding - Scratch - Small / (L) Rear Door, Molding - Scratch - Small / (L) Rear Fender, Molding - Scratch - Small</p> |
