## General Information

| Make | Toyota | Model | Vios |

## Body / Panel Condition

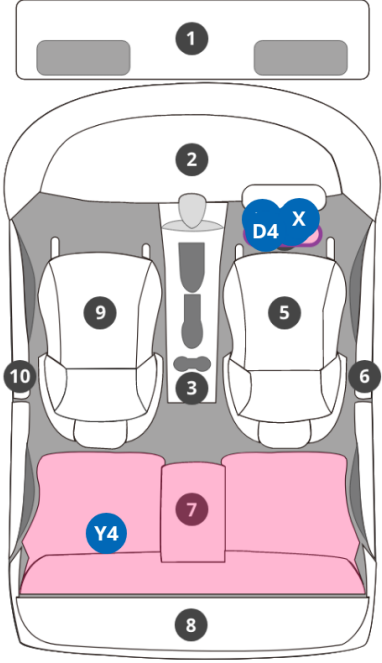
| Interior Evaluation : <span style="color: red; font-weight: bold;">C</span> | Exterior Evaluation : <span style="color: red; font-weight: bold;">E</span> |
| <p><b>Remarks</b></p> <p>Rear Seat - Grime - Large / (R) Front Floor Mat - Missing - Yes / (L) Front Floor Mat - Missing - Yes / Mat Other - Missing - Yes / Carpet - Worked - Large</p> | <p><b>Remarks</b></p> <p>Front Bumper, Grille, Lamps - Crack, Gap - Large / Bonnet, Headlight - Crack, Gap - Large / (R) Rear Fender, Molding - Scratch &amp; Dent - Large / Rear Bumper, Lamps, Panels - Crack, Gap - Large / (R) Rear Door, Molding - Scratch &amp; Dent - Small / (R) Front Fender, Molding - Dent - Medium / (L) Front Door, Molding - Scratch - Medium / Roof - Dent - Small / (L) Rear Door, Molding - Scratch - Minimal / (L) Rear Fender, Molding - Scratch - Small / (R) Front Door, Molding - Scratch - Small / (L) Front Fender, Molding - Dent - Medium</p> |

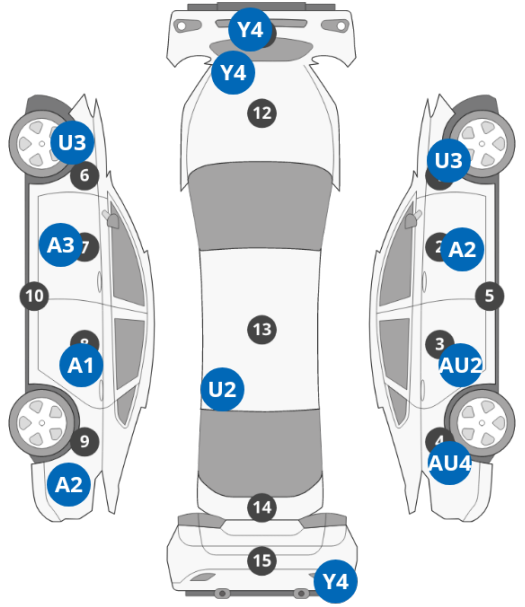
| Inspector Notes |
|---|
| <p>with warranty booklet/ with spare tire and jack/ no LTO plate/ no tools/ warning lamp(check engine and power steering issue/ head lights issue (mis aligned) / tail light issue ( cracked )</p> |
