## General Information

| Make | Toyota | Model | Vios |

## Body / Panel Condition

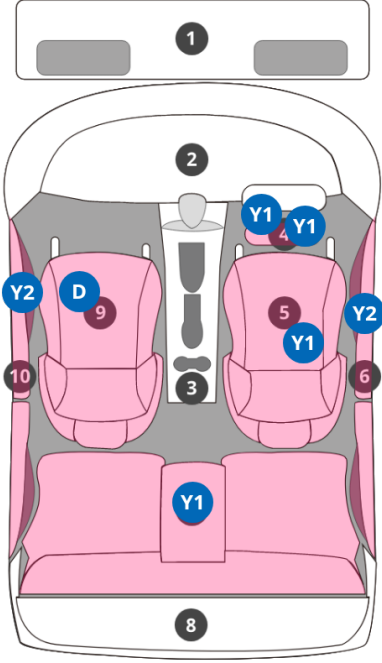
| Interior Evaluation : <span style="color: red;">C</span> | Exterior Evaluation : <span style="color: red;">C</span> |
| <p><b>Remarks</b></p> <p>(R) Front Trim - Grime - Small / (L) Front Trim - Grime - Small / (R) Front Floor Mat - Grime - Minimal / (L) Front Floor Mat - Grime - Minimal / (R) Front Seat - Grime - Minimal / (L) Front Seat - Worn - Yes / Rear Seat - Grime - Minimal / Overall Interior - Worn as per age - Yes</p> | <p><b>Remarks</b></p> <p>Bonnet, Headlight - Scratch - Small / (R) Front Fender, Molding - Scratch - Minimal / (R) Front Door, Molding - Scratch - Small / (R) Rear Door, Molding - Scratch - Small / (R) Step, In-panel, Side Spoiler - Scratch - Small / (R) Rear Fender, Molding - Scratch - Small / Trunk Hood, Rear Gate - Scratch - Minimal / Rear Bumper, Lamps, Panels - Scratch - Small / (L) Rear Fender, Molding - Scratch - Small / (L) Rear Door, Molding - Scratch - Small / (L) Step, In-panel, Side Spoiler - Scratch - Small / (L) Front Door, Molding - Scratch - Minimal / Front Bumper, Grille, Lamps - Scratch - Small / Roof - Dent - Small</p> |
