## General Information

| Make | Toyota | Model | Avanza |
| YOM | 2021 | Odo Meter Reading | 95,707 |
| Registration No. | NGB6043 | Chassis No. | MHKM5EE2FLK016055 |

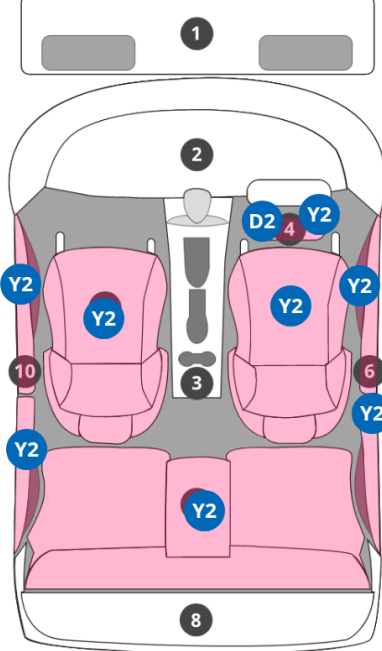
| Interior Evaluation : <b>B</b> | Exterior Evaluation : <b>D</b> |
| <b>Remarks</b><br>(L) Front Trim - Grime - Small / (R) Front Trim - Grime - Small / (R) Rear Trim - Grime - Small / (L) Rear Trim - Grime - Small / (R) Front Seat - Grime - Small / (L) Front Seat - Grime - Small / Rear Seat - Grime - Small / (R) Front Floor Mat - Grime - Small / (L) Front Floor Mat - Worked - Small | <b>Remarks</b><br>(R) Front Fender, Molding - Scratch - Small / (R) Front Door, Molding - Scratch - Small / (R) Step, In-panel, Side Spoiler - Scratch - Small / (R) Rear Fender, Molding - Scratch & Dent - Small / (R) Rear Door, Molding - Scratch & Dent - Medium / Rear Bumper, Lamps, Panels - Scratch - Small / Trunk Hood, Rear Gate - Scratch - Small / (L) Rear Fender, Molding - Scratch - Small / (L) Rear Door, Molding - Scratch - Small / (L) Step, In-panel, Side Spoiler - Scratch - Small / (L) Front Door, Molding - Scratch & Dent - Small / (L) Front Fender, Molding - Scratch - Small / Front Bumper, Grille, Lamps - Scratch - Medium / Bonnet, Headlight - Scratch - Small / Roof - Scratch - Small |
