General Information

Make	Toyota	Model	Vios
YOM	2024	Mileage	14,750
Registration No.	NHR9841	Chassis No.	PA1B18F37P4234939
CC	1.3	Transmission	CVT
Fuel Type	Gas	Type of Body	Sedan
Colour	Silver

Body / Panel Condition

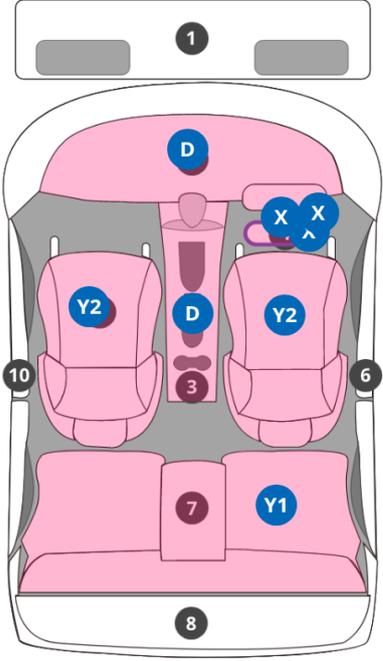
Interior Evaluation : B	Exterior Evaluation : C

<p>a : Cut, Fray d : Loose, Deformed k : Animal Hair s : Smell t : Cigarette Burns x : Defective y : Stain</p>

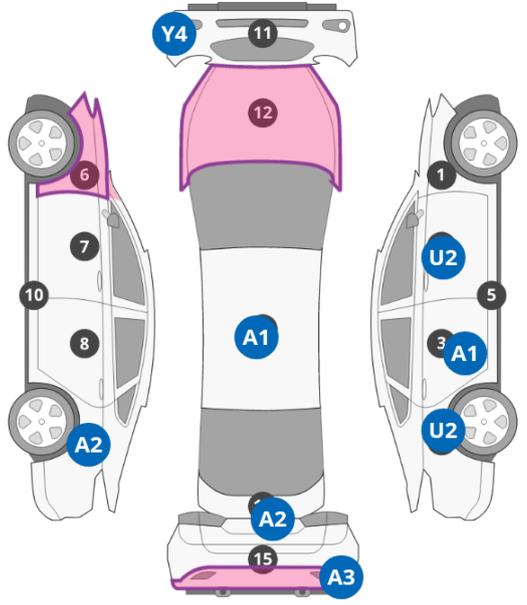
<p>A : Scratch AU : Scratch & Dent B : Modified C : Corrosion G : Stone chip P : Faded S : Rust SC : Rust & Corrosion U : Dent X : Defective Y : Crack, Gap</p>
<p>Remarks (R) Front Floor Mat - Missing - Yes / (L) Front Floor Mat - Missing - Yes / Mat Other - Missing - Yes / Dashboard - Traces of Adhesive Tape - Yes / Console, Switches, Vents - Traces of Adhesive Tape - Yes / Rear Seat - Grime - Minimal / (L) Front Seat - Grime - Small / (R) Front Seat - Grime - Small</p>	<p>Remarks (L) Front Fender - Repair Traces - Yes / Front Bumper, Grille, Lamps - Crack, Gap - Large / (L) Front Fender, Molding - Repair mark - Yes / Rear Bumper, Lamps, Panels - Scratch - Medium / (R) Rear Fender, Molding - Dent - Small / Trunk Hood, Rear Gate - Scratch - Small / Bonnet, Headlight - Repair mark - Difference in Color / (R) Rear Door, Molding - Scratch - Minimal / (R) Front Door, Molding - Dent - Small / Roof - Scratch - Minimal / (L) Rear Fender, Molding - Scratch - Small / Rear Bumper, Lamps, Panels - Repair mark - Difference in Color</p>
