General Information

Make	Jeep	Model	Cherokee
YOM	2015	Mileage	61,682
Registration No.	ABF2556	Chassis No.	1C4PJMDB0FW582881
CC	2.4	Transmission	A/T
Fuel Type	Gas	Type of Body	SUV
Colour	Blue

Body / Panel Condition

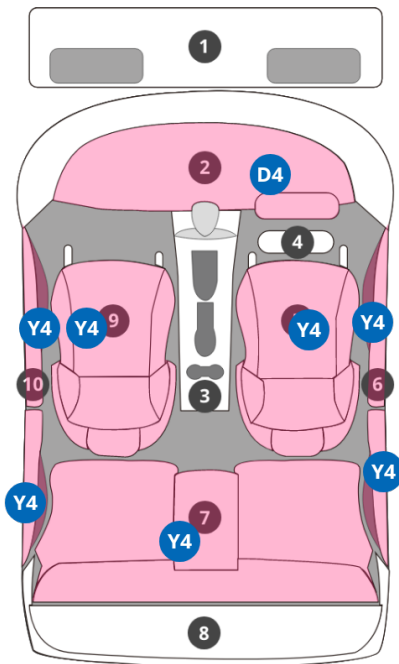
Interior Evaluation : E	Exterior Evaluation : E

<p>a : Cut, Fray d : Loose, Deformed k : Animal Hair s : Smell t : Cigarette Burns x : Defective y : Stain</p>

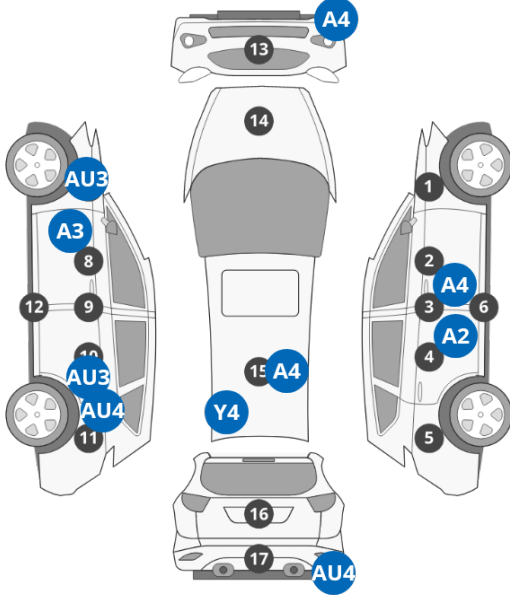
<p>A : Scratch AU : Scratch & Dent B : Modified C : Corrosion G : Stone chip P : Faded S : Rust SC : Rust & Corrosion U : Dent X : Defective Y : Crack, Gap</p>
<p>Remarks (L) Rear Trim - Grime - Large / Rear Seat - Grime - Large / (L) Front Trim - Grime - Large / (L) Front Seat - Grime - Large / (R) Front Seat - Grime - Large / Dashboard - Worked - Large / (R) Front Trim - Grime - Large / (R) Rear Trim - Grime - Large</p>	<p>Remarks (R) Front Door - Repair Traces - Yes / (R) Front Fender - Repair Traces - Yes / Bonnet - Repair Traces - Yes / (L) Front Fender - Repair Traces - Yes / (L) Front Door - Repair Traces - Yes / (L) Step - Repair Traces - Yes / (L) Rear Door - Repair Traces - Yes / (L) Rear Fender - Repair Traces - Yes / Trunk Hood, Rear Gate - Repair Traces - Yes / (R) Rear Fender - Repair Traces - Yes / (R) Rear Door - Repair Traces - Yes / Roof - Repair Traces - Yes / (L) Front Fender, Molding - Scratch & Dent - Medium / (L) Front Door, Molding - Scratch - Medium / (L) Rear Door, Molding - Scratch & Dent - Medium / (L) Rear Fender, Molding - Scratch - Medium / (L) Rear Windshield - Damaged - Large / Rear Bumper, Lamps, Panels - Scratch & Dent - Large / (R) Rear Door, Molding - Scratch - Small / (R) Front Door, Molding - Scratch - Large / Front Bumper, Grille, Lamps - Scratch - Large / Roof - Scratch - Large</p>
