## General Information

| Make | Toyota | Model | Vios |

## Body / Panel Condition

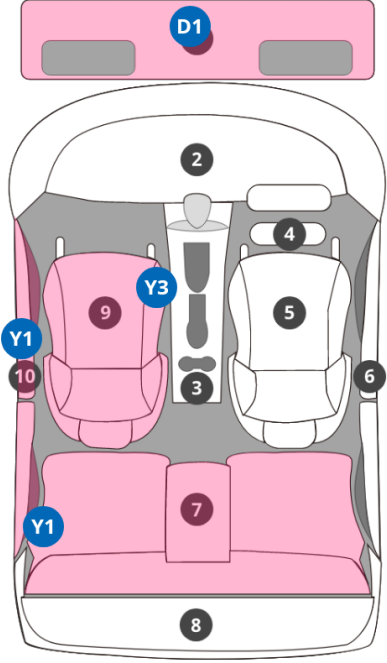
| <b>Remarks</b><br>Ceiling - Crinkle - Minimal / Rear Seat - Grime - Minimal / (L) Front Seat - Grime - Medium / (L) Front Trim - Grime - Minimal | <b>Remarks</b><br>(R) Front Fender, Molding - Scratch - Minimal / (R) Front Wheel, Cover - Scratch, Corrosion - Small / (R) Front Door, Molding - Scratch - Large / (R) Rear Door, Molding - Scratch - Small / (R) Rear Fender, Molding - Modified - Medium / Rear Bumper, Lamps, Panels - Scratch - Small / Trunk Hood, Rear Gate - Scratch & Dent - Medium / (L) Rear Fender, Molding - Scratch - Minimal / (L) Rear Door, Molding - Scratch - Small / Roof - Scratch & Dent - Small / (L) Front Door, Molding - Scratch & Dent - Minimal / (L) Front Wheel, Cover - Scratch, Corrosion - Small / Front Bumper, Grille, Lamps - Scratch - Minimal / Bonnet, Headlight - Scratch & Dent - Minimal / (L) Front Fender, Molding - Scratch - Minimal |

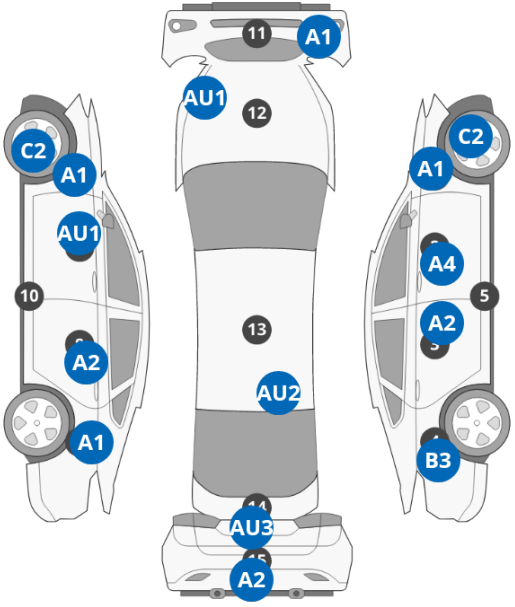
| Inspector Notes |
|---|
| No LTO plate/with warranty booklet/with jack and tools/with spare tire/paint and stain on rear bumper and trunk and left rear door |
